Subject: ADA Assessment of City Library and Senior Center

**City of South Pasadena
Disabled Access Assessment
for the
Library and Senior Center**

Prepared by
Transtech Engineers, Inc.
April 21, 2006

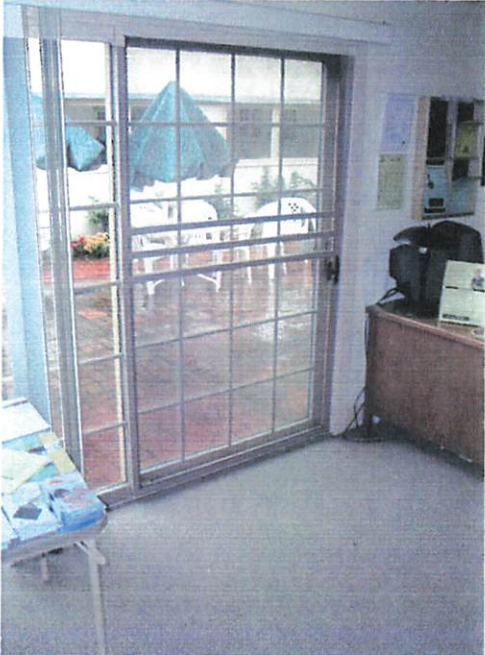
Image	Description	Associated Code Section¹
<p>1.</p>

<p>Location: Between administrative area and west side patio area – southern sliding door.</p> <p>Noncomplying Condition: Door threshold.</p> <p>Effort to Correct: Significant</p> <p>Cost to Correct: \$\$\$\$</p> <p>Suggested Corrective Action: Relevel the unmortared brick patio at just below interior floor level and replace the siding glass door with a complying sliding glass door or fill opening with a window and complying swinging door.</p>	<p><u>CBC</u> 2-1133B.1.1.1 2-1133B.2.4.1</p> <p><u>ADAAG</u> 4.13.8</p>

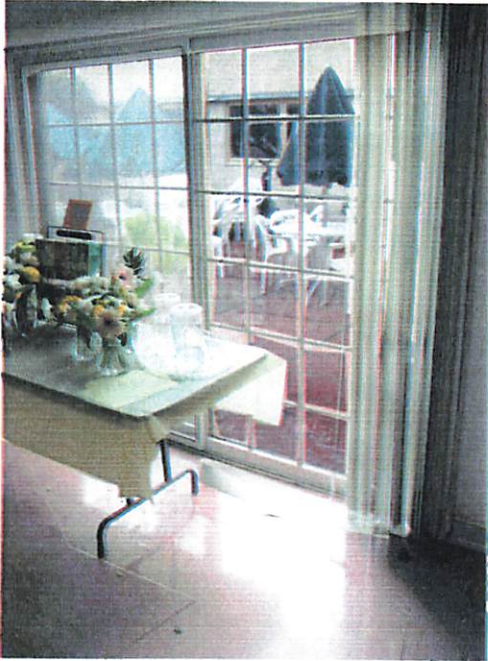
<p>Location: Between administrative area and west side patio area – northern sliding door.</p> <p>Noncomplying Condition: Door threshold.</p> <p>Effort to Correct: Significant</p> <p>Cost to Correct: \$\$\$\$</p> <p>Suggested Corrective Action: Relevel the unmortared brick patio at just below interior floor level and replace the sliding glass door with a complying sliding glass door or fill opening with a window and complying swinging door.</p>	<p><u>CBC</u> 2-1133B.1.1.1 2-1133B.2.4.1</p> <p><u>ADAAG</u> 4.13.8</p>
<p>3.</p>

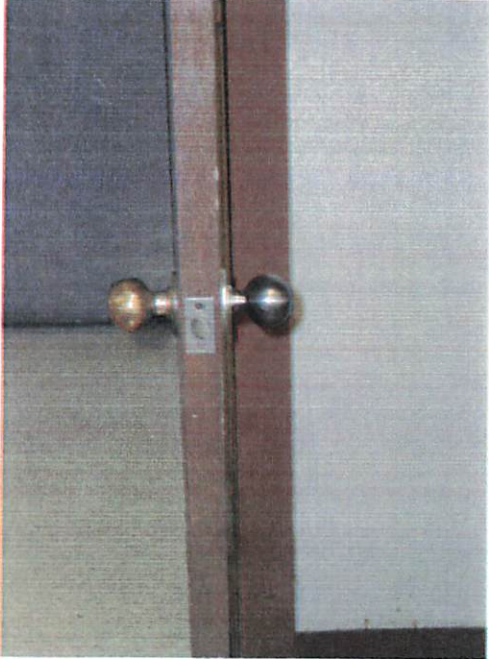
<p>Location: Various locations throughout the building.</p> <p>Noncomplying Condition: Door knob.</p> <p>Effort to Correct: Negligible</p> <p>Cost to Correct: \$</p> <p>Suggested Corrective Action: Replace noncomplying door knobs with complying lever door hardware.</p>	<p><u>CBC</u> 2-1133B.2.5.2</p> <p><u>ADAAG</u> 4.13.9</p>

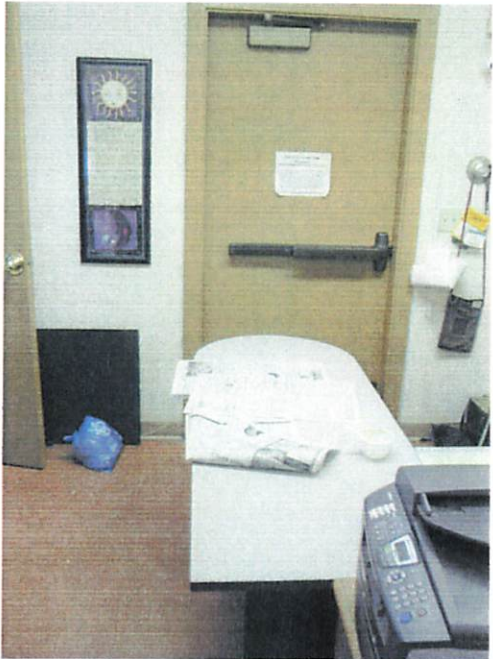
<p>4.</p>

<p>Location: Administrative Area at northeast exterior door.</p> <p>Noncomplying Condition: Inadequate width in path of travel to exterior door.</p> <p>Effort to Correct: Minimal</p> <p>Cost to Correct: \$</p> <p>Suggested Corrective Action: Reconfigure desk/work area.</p>	<p>CBC 2-1105B.3.2 2-1105B.3.6(1)</p> <p>ADAAG 4.2.1</p>
<p>5.</p>

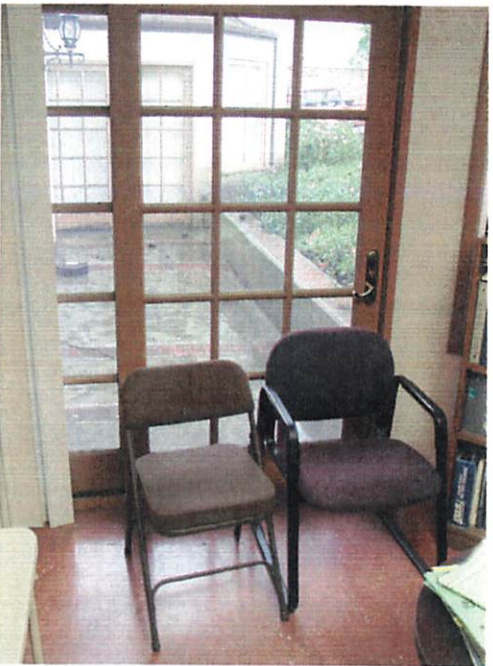
<p>Location: Clerical area at north patio – two locations, one on each side of the exterior patio.</p> <p>Noncomplying Condition: Door threshold.</p> <p>Effort to Correct: Significant</p> <p>Cost to Correct: \$\$\$</p> <p>Suggested Corrective Action: Replace door with complying door, and construct complying exterior landing as required.</p>	<p>CBC 2-1133B.1.1.1 2-1133B.2.4.1</p> <p>ADAAG 4.13.8</p>

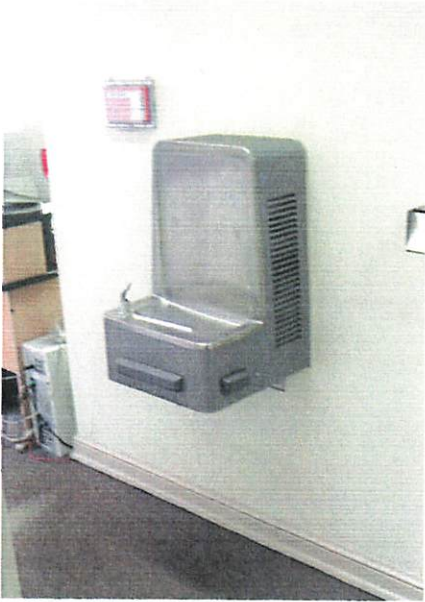
<p>6.</p>

<p>Location: Adjacent to the public restrooms.</p> <p>Noncomplying Condition: No high/low drinking fountain. Bubbler orifice is not at a correct height. Not located within an alcove or protected by wing rails.</p> <p>Effort to Correct: Significant.</p> <p>Cost to Correct: \$\$</p> <p>Suggested Corrective Action: Install complying “high/low” drinking fountain combination and protect with tactile floor surface and wing rails.</p>	<p><u>CBC</u> 1115B.2.1.5.1 1117B.1.1 1117B.1.2</p> <p><u>ADAAG</u> 4.15.2 4.15.4</p>
<p>7.</p> <p style="text-align: center;">No Photograph</p>	<p>Door closers should not require more than 5 pounds to operate except that fire-rated door assemblies may require not more than 15 pounds of force to operate. All doors not in compliance should be adjusted or have the closer replaced.</p>	<p><u>CBC</u> 2-1133B.2.5 2-1133B.2.5.1 2-1133B.2.5.2</p> <p><u>ADAAG</u> 4.13.10 4.13.11</p>

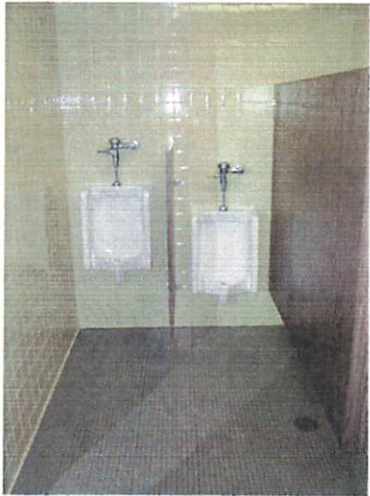
Image	Description	Associated Code Section ¹
<p>11.

</p>	<p>Location: Men's restroom.</p> <p>Noncomplying Condition: Men's urinal is 24" above floor (the maximum permitted is 17") and the urinal projects 13" from the wall (14" is the minimum permitted projection).</p> <p>Effort to Correct: Significant.</p> <p>Cost to Correct: \$\$\$</p> <p>Suggested Corrective Action: Replace and lower one urinal.</p>	<p><u>CBC</u> 2-1115B.2.1.1.1</p> <p><u>ADAAG</u> 4.18.2</p>

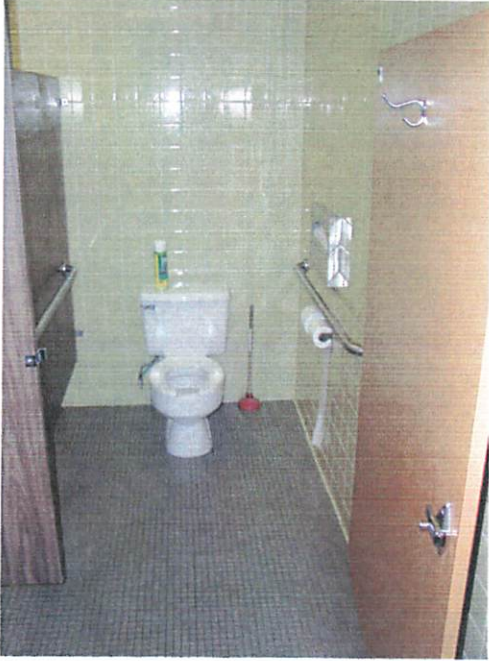
<p>12.</p>

<p>Location: Men's restroom.</p> <p>Noncomplying Condition: Toilet seat height is too low. The toilet is located too close to the wall and too far from the partition divider. Grab bar is missing from the back wall (behind the toilet) for fully complying condition. Flush control is required to be on the wide side for ADA.</p> <p>Effort to Correct: Significant.</p> <p>Cost to Correct: \$\$ to \$\$\$</p> <p>Suggested Corrective Action: Option No. 1: <i>[Permitted Equivalent Facilitation]</i> Replace the toilet and relocate the partition wall so that the face of the partition is 18" from the centerline of the toilet. Option No. 2: <i>[Full Compliance]</i> Replace and relocate the toilet to a complying location. Relocate the partitions as required. Install complying grab bars.</p>	<p>CBC 2-1115B.2.1 2-1115B.7.1(3) 2-1115B.2.1(2)</p> <p>ADAAG 4.16.3 4.16.5 4.17.3</p>
<p>13.</p>

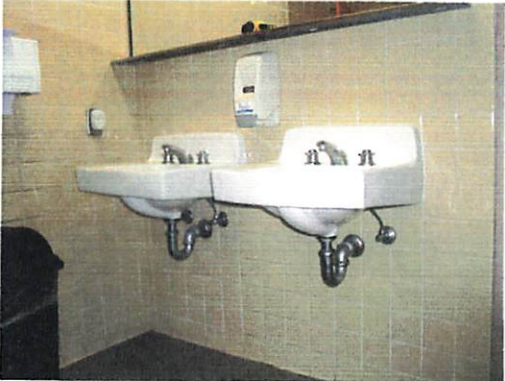
<p>Location: Men's Restroom</p> <p>Noncomplying Condition: Faucet valves. Hot water and drain piping is not wrapped.</p> <p>Effort to Correct: Minor</p> <p>Cost to Correct: \$\$</p> <p>Suggested Corrective Action: At a minimum, replace the faucet valves on the sink closest to the door. Wrap the hot water and drainage piping.</p>	<p>CBC 2-1115B.2.1.2.1 2-1115B.2.1.2.2</p> <p>ADAAG 4.19.4 4.19.5</p>

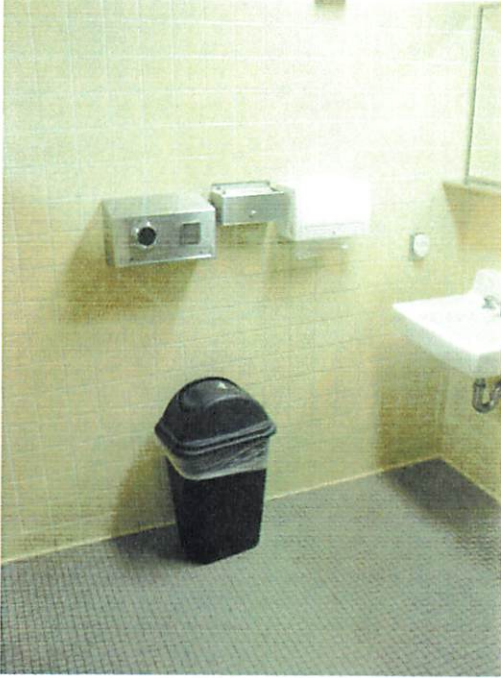
<p>14.</p>

<p>Location: Men's restroom.</p> <p>Noncomplying Condition: Hand dryer, ashtray, and paper towel dispenser are all mounted too high above the floor.</p> <p>Effort to Correct: Negligible</p> <p>Cost to Correct: \$</p> <p>Suggested Corrective Action: Lower the hand dryer, remove the ashtray, and lower or install a complying paper towel dispenser.</p>	<p><u>CBC</u> 2-1115B.9.2</p> <p><u>ADAAG</u> 4.27.3</p>
<p>15.</p>

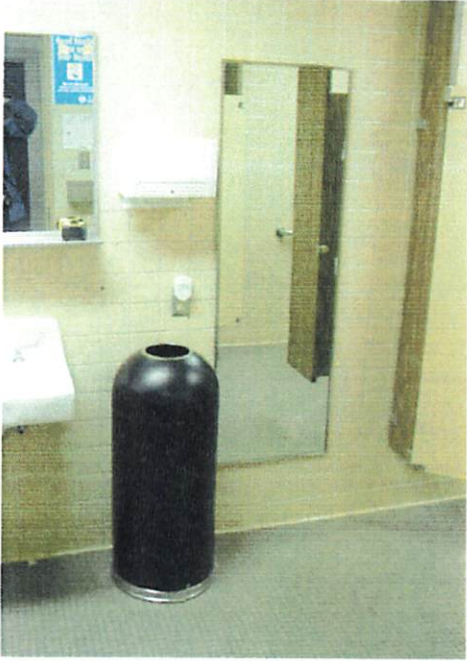
<p>Location: Women's Restroom</p> <p>Noncomplying Condition: Paper towel dispenser is mounted too high. Hot water and drain piping is not wrapped.</p> <p>Effort to Correct: Negligible</p> <p>Cost to Correct: \$</p> <p>Suggested Corrective Action: Lower the paper towel dispenser to the correct height above the floor or install a second dispenser at no more than 40" above the floor. Wrap the hot water and drain piping.</p>	<p><u>CBC</u> 2-1115B.9.2 2-1115B.2.1.2.2</p> <p><u>ADAAG</u> 4.19.4 4.27.3</p>

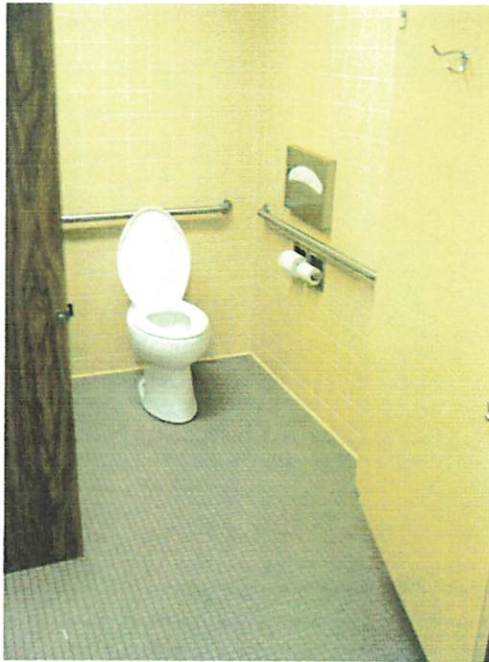
16.

Noncomplying Condition:

Toilet seat height is too low. The toilet is located too close to the wall and too far from the partition divider. Control for the flush valve is located on the wrong side of the toilet. Grab bar is missing from the back wall (behind the toilet) for fully complying condition.

Effort to Correct: Significant.

Cost to Correct: \$\$ to \$\$\$

Suggested Corrective Action:

Option No. 1: *[Permitted Equivalent Facilitation]* Replace the toilet and relocate the partition wall so that the face of the partition is 18" from the centerline of the toilet.

Option No. 2: *[Full Compliance]* Replace and relocate the toilet to a complying location. Relocate the partitions as required. Install complying grab bars.

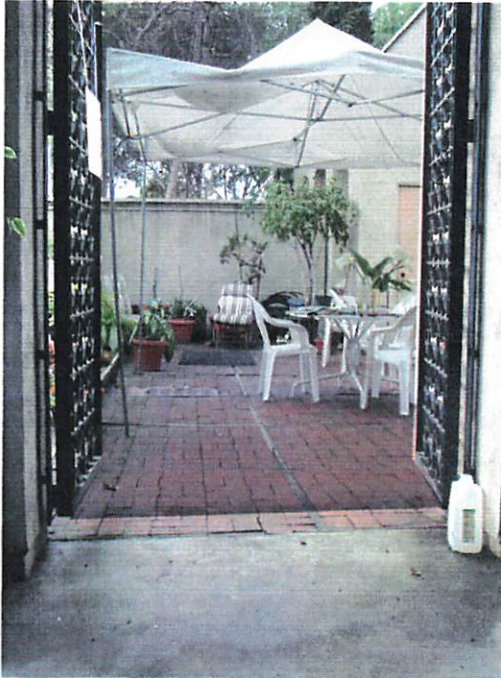
Image	Description	Associated Code Section ¹
<p>17.</p>

<p>Location: Doors and entrances serving the patio area located on the west side of the senior center. The following photographs indicate a variety of noncomplying floor surface, door threshold, and door latch conditions.</p> <p>Noncomplying Condition: Uneven surface, unpermitted vertical discontinuity, and/or excessive cross-slope. Round door knobs.</p> <p>Effort to Correct: Significant to major.</p> <p>Cost to Correct: \$\$\$ to \$\$\$\$.</p> <p>Suggested Corrective Action: Patio area abuts several exterior doors or other entrances with noncomplying exterior door landing conditions. The patio and these door conditions can be simultaneously corrected by releveling the patio at a higher elevation. Brick pavers are not mortared in place and could be reused in a sand-bedded installation which would help minimize the cost.</p>	<p style="text-align: center;"><u>CBC</u> 2-1124B.1 thru 2-1124B.4 2-1133B.2.4.1 2-1133B.2.5.2</p> <p style="text-align: center;"><u>ADAAG</u> 4.3.7 4.3.8 4.5.1 4.5.2 4.13.8 4.13.9</p>

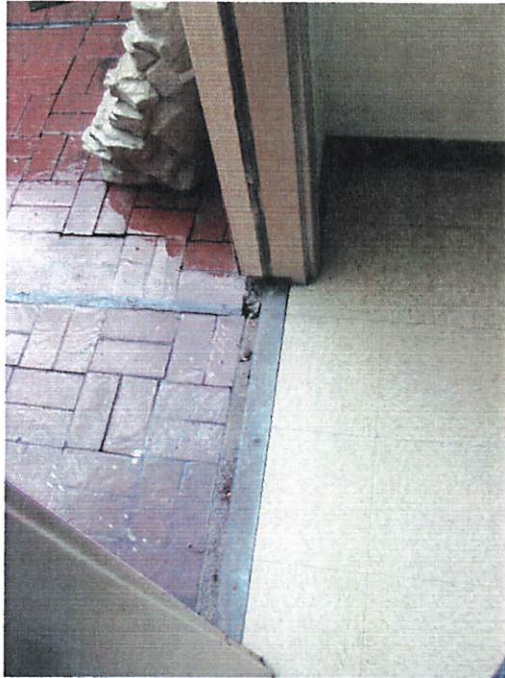
20.

See Item Number 17 for related information.

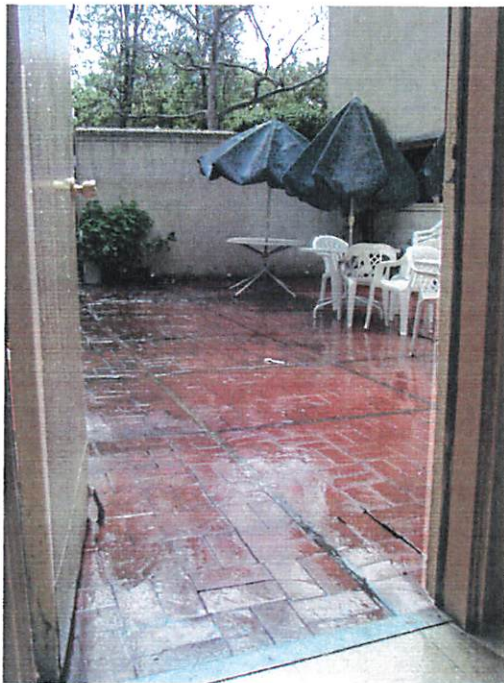
21.

See Item Number 17 for related information.

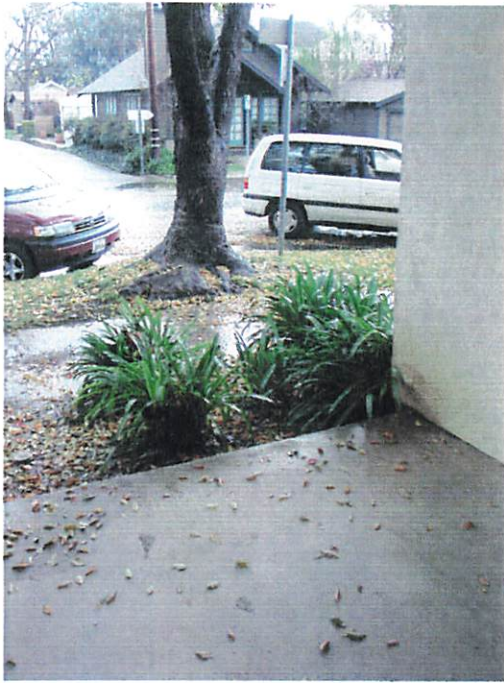
22.

Location: East side of Senior Center adjacent to administrative offices – two (2) exterior doors serve this location..

Noncomplying Condition: Condition fails to comply with disabled access requirements and the California Building Code for safe exiting.

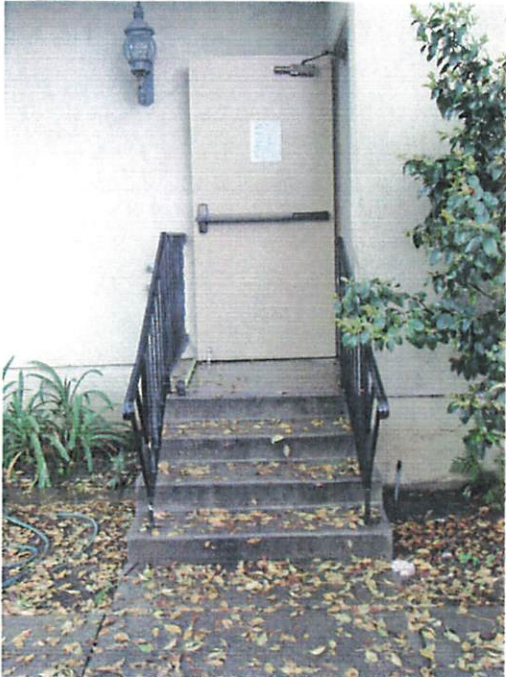
<p>23.</p>

<p>Location: East side of Senior Center (Exit from main room).</p> <p>Noncomplying Condition: Door landing and handrails.</p> <p>Effort to Correct: Depends on action; Minor to Significant.</p> <p>Cost to Correct: \$\$ to \$\$\$</p> <p>Suggested Corrective Action: Option No. 1: <i>[Permitted Equivalent Facilitation]</i> Replace the existing handrail with a handrail that provides the proper handgrip cross-section and extensions at the top and bottom of the stair. Add required visual stripping, and signage indicating that the door does not provide a disabled access-complying means of egress. Option No. 2: <i>[Full Compliance]</i> Remove existing landing and stairway and construct new landing and ramp to City sidewalk grade elevation.</p>	<p><u>CBC</u> 2-1133B.1.1.1.1 2-1133B.2.4.1 2-1133B.4.1.1 2-1133B.4.2.1 2-1133B.4.2.2 2-1133B.4.2.6.1 2-1133B.4.2.6.2 2-1133B.4.4</p> <p><u>ADAAG</u> 4.9 4.13.8</p> <p><u>CBC</u> <u>Tactile Exit Signage</u> <u>Requirements¹</u> 2-1003.2.8.6 2-1003.2.8.6.1</p>

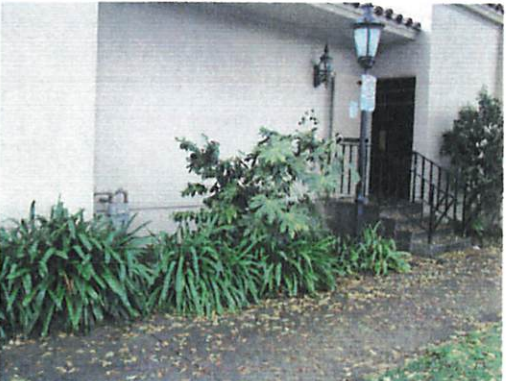
<p>24.</p>

<p>See Item Number 23 for related information.</p>

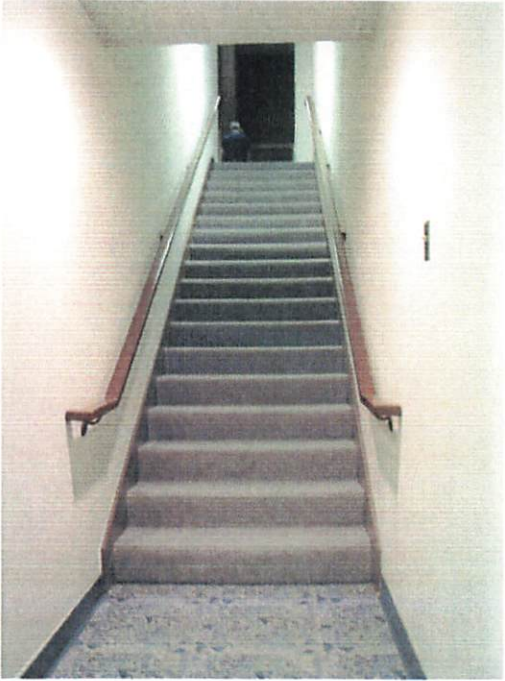
Image	Description	Associated Code Section ¹
<p>1.

</p>	<p>Location: Interior stair to second floor.</p> <p>Noncomplying Condition: Handrails and stair level signage. No visual striping.</p> <p>Effort to Correct: Minor</p> <p>Cost to Correct: \$\$</p> <p>Suggested Corrective Action: Replace handrails with complying handrails mounted at the correct height.</p>	<p style="text-align: center;"><u>CBC</u> 2-1133B.4.2.1 2-1133B.4.2.2 2-1133B.4.2.6.1 2-1133B.4.3 2-1133B.4.4 2-1117B.5</p> <p style="text-align: center;"><u>ADAAG</u> 4.9.4</p> <p style="text-align: center;"><u>CBC</u> <u>Tactile Exit Signage</u> <u>Requirements</u>² 2-1003.2.8.6 2-1003.2.8.6.1</p>

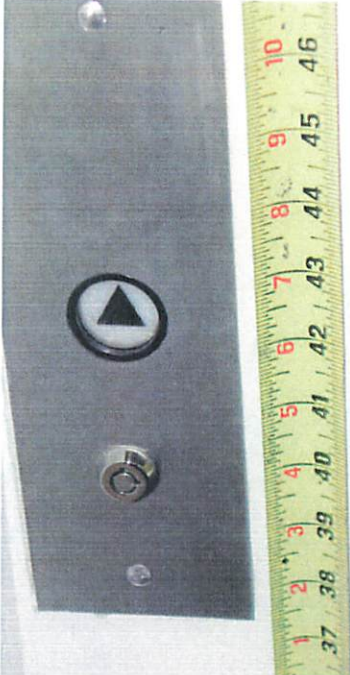
<p>2.</p>

<p>Location: Library Elevator.</p> <p>Noncomplying Condition: Lack of raised button. No braille information. No star at ground floor.</p> <p>Effort to Correct: Minor</p> <p>Cost to Correct: \$\$</p> <p>Suggested Corrective Action: Replace button with complying button.</p>	<p><u>CBC</u></p> <p><u>ADAAG</u> 4.10.3 4.10.12</p>
<p>3.</p>

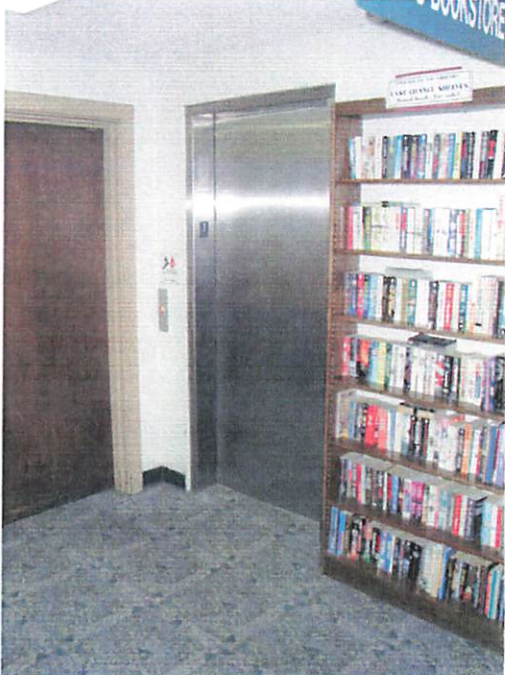
<p>Location: Library Elevator.</p> <p>Noncomplying Condition: No hall lantern. No raised braille characters on each side of entrance. Noncomplying audible signals and car position indicators.</p> <p>Effort to Correct: Minor to Significant.</p> <p>Cost to Correct: \$\$\$</p> <p>Suggested Corrective Action: Install appropriate information and/or systems.</p>	<p><u>CBC</u></p> <p><u>ADAAG</u> 4.10.4 4.10.5 4.10.13</p>

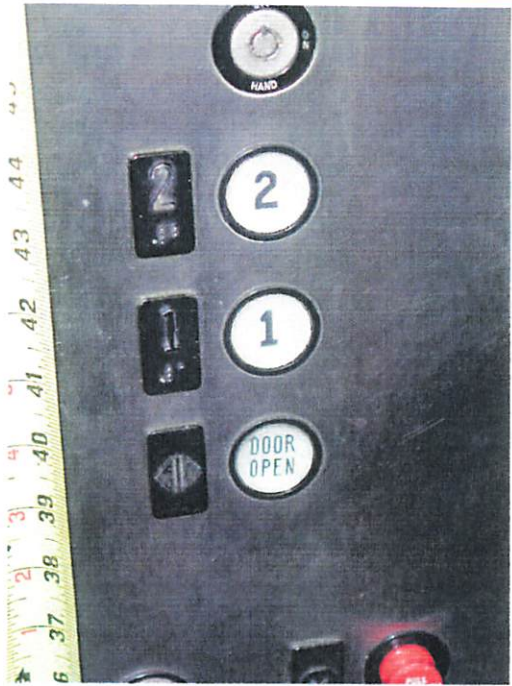
<p>4.</p>

<p>Location: Library Elevator.</p> <p>Noncomplying Condition: No star at first floor button.</p> <p>Effort to Correct: Negligible</p> <p>Cost to Correct: \$</p> <p>Suggested Corrective Action: Install required braille symbol.</p>	<p><u>CBC</u></p> <p><u>ADAAG</u> 4.10.12</p>
<p>5.</p>

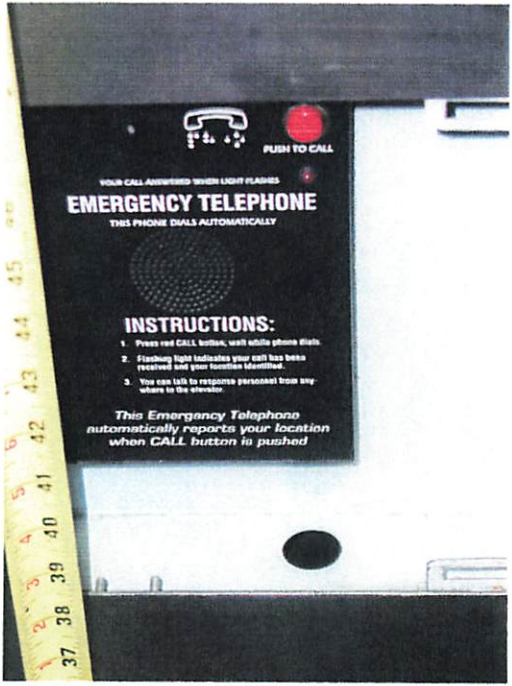
<p>Location: Library Elevator.</p> <p>Noncomplying Condition: Emergency communication lacks braille information and requires voice communication.</p> <p>Effort to Correct: Unknown</p> <p>Cost to Correct: Unknown</p> <p>Suggested Corrective Action: Replace emergency telephone with complying system.</p>	<p><u>CBC</u></p> <p><u>ADAAG</u> 4.10.14</p>

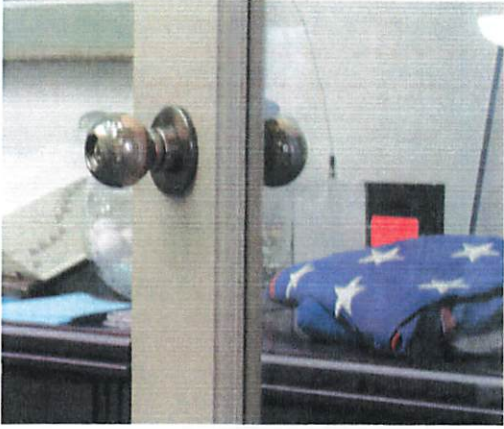
<p>6.</p>

<p>Location: City Librarian's Office and various other staff locations.</p> <p>Noncomplying Condition: Round door knob.</p> <p>Effort to Correct: Negligible</p> <p>Cost to Correct: \$</p> <p>Suggested Corrective Action: Replace the door knob with complying lever hardware.</p>	<p><u>CBC</u> 2-1133B.2.5.2</p> <p><u>ADAAG</u> 4.13.9</p>
<p>7.</p>

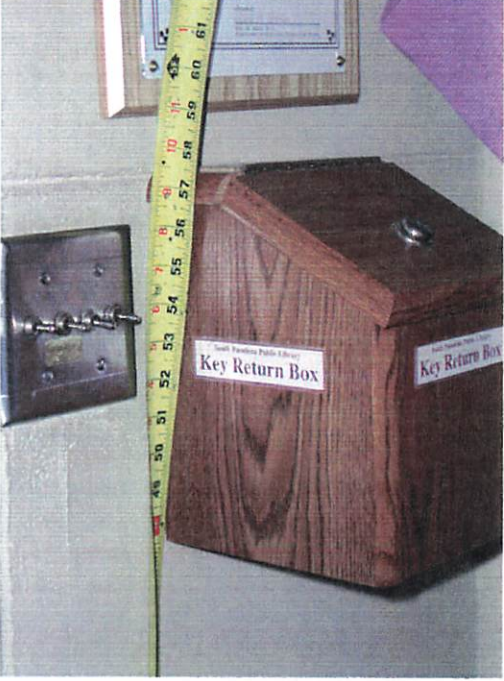
<p>Location: Community Room</p> <p>Noncomplying Condition: Key return box mounted to high.</p> <p>Effort to Correct: Negligible</p> <p>Cost to Correct: \$</p> <p>Suggested Corrective Action: Lower the box.</p>	<p><u>CBC</u> 2-1118B.6</p> <p><u>ADAAG</u> 4.27.3</p>

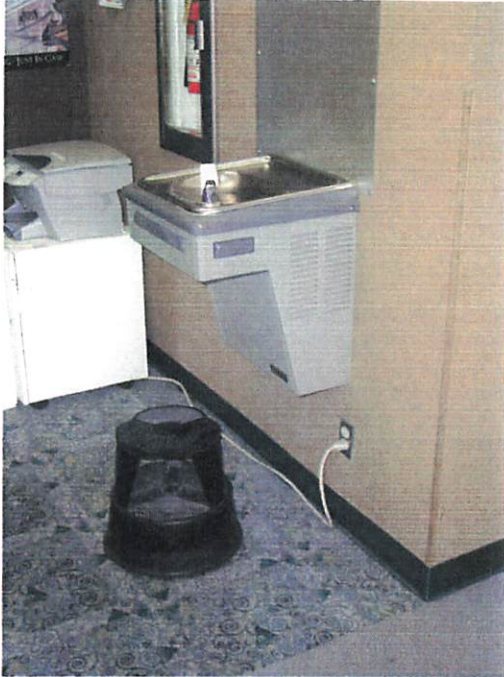
<p>8.</p>

<p>Location: Adjacent to the first floor public restrooms.</p> <p>Noncomplying Condition: No high/low drinking fountain. Bubbler orifice is not located at a correct height. Not located within an alcove or protected by wing rails.</p> <p>Effort to Correct: Significant.</p> <p>Cost to Correct: \$\$</p> <p>Suggested Corrective Action: Install complying “high/low” drinking fountain combination and protect with tactile floor surface and wing rails.</p>	<p>CBC 1115B.2.1.5.1 1117B.1.1 1117B.1.2</p> <p>ADAAG 4.15.2 4.15.4</p>
<p>9.</p>

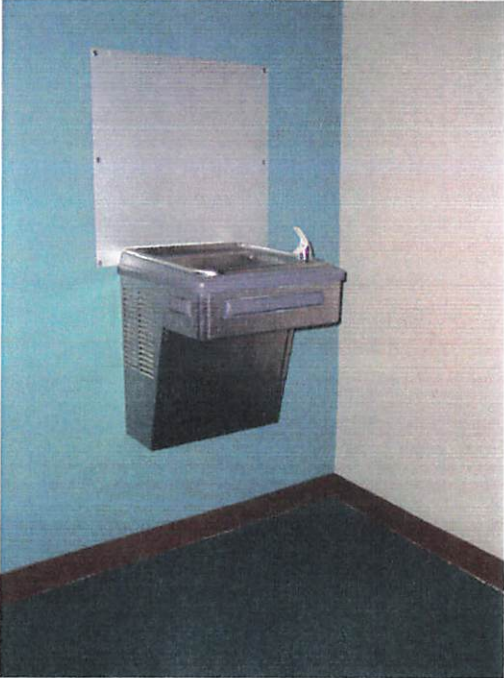
<p>Location: Second floor adjacent to the top of the interior stairs.</p> <p>Noncomplying Condition: No high/low drinking fountain. Bubbler orifice is not located at a correct height. Not located within an alcove or protected by wing rails.</p> <p>Effort to Correct: Significant.</p> <p>Cost to Correct: \$\$</p> <p>Suggested Corrective Action: Install complying “high/low” drinking fountain combination and protect with tactile floor surface and wing rails.</p>	<p>CBC 1115B.2.1.5.1 1117B.1.1 1117B.1.2</p> <p>ADAAG 4.15.2 4.15.4</p>

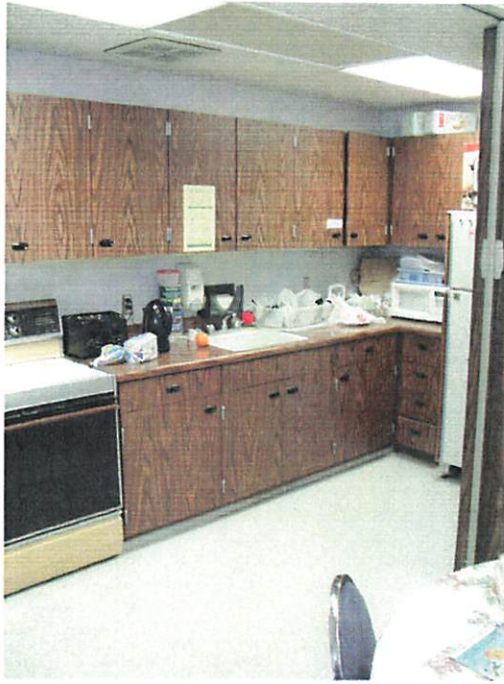
<p>10.</p>

<p>Location: Upstairs Staff Kitchen/Break Area</p> <p>Noncomplying Condition: No specific code violations except possibly for reach, but existing facility makes no attempt to be "disabled user-friendly."</p> <p>Effort to Correct: None currently required, but issue should be addressed at a point where City staff is considering a remodel of this area.</p> <p>Cost to Correct: 0</p> <p>Suggested Corrective Action: None at this time.</p>	<p><u>CBC</u> For reference, see 2-1118B.5 and 2-1118B.6</p> <p><u>ADAAG</u> 4.2.5 4.2.6</p>
<p>11.</p>

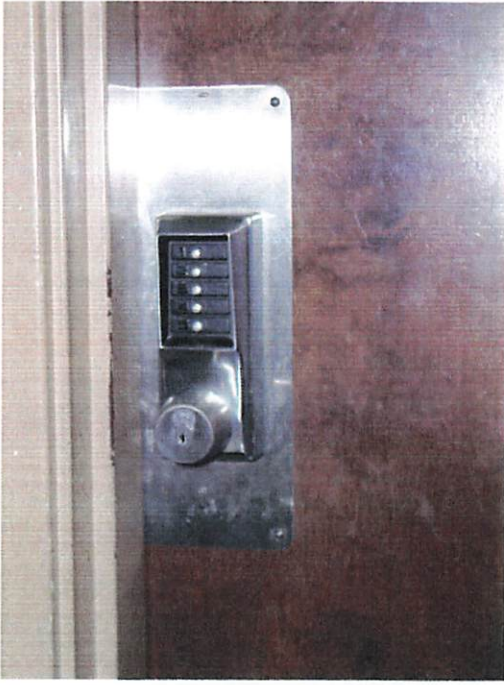
<p>Location: Upstairs Staff Kitchen/Break Area</p> <p>Noncomplying Condition: Security hardware with four (4) buttons and a door knob that requires tight grasping.</p> <p>Effort to Correct: Negligible to Minor depending on replacement security hardware chosen.</p> <p>Cost to Correct: \$ to \$\$</p> <p>Suggested Corrective Action: Replace the security hardware with complying door hardware.</p>	<p><u>CBC</u> 1133B2.5.2</p>

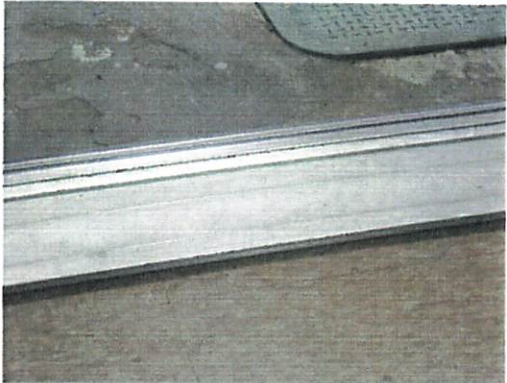
<p>12.</p>

<p>Location: Door threshold to first floor electric/telecomm room.</p> <p>Noncomplying Condition: Door threshold height. (Existing condition also violates California Building Code door threshold height requirements.)</p> <p>Effort to Correct: Minor</p> <p>Cost to Correct: \$ to \$\$</p> <p>Suggested Corrective Action: Remove and replace with a complying door threshold.</p>	<p><u>CBC</u> 2-1133B.2.4.1</p> <p>2-1003.3.1.6 (exiting)</p> <p><u>ADAAG</u> 4.13.8</p>
<p>13.</p>

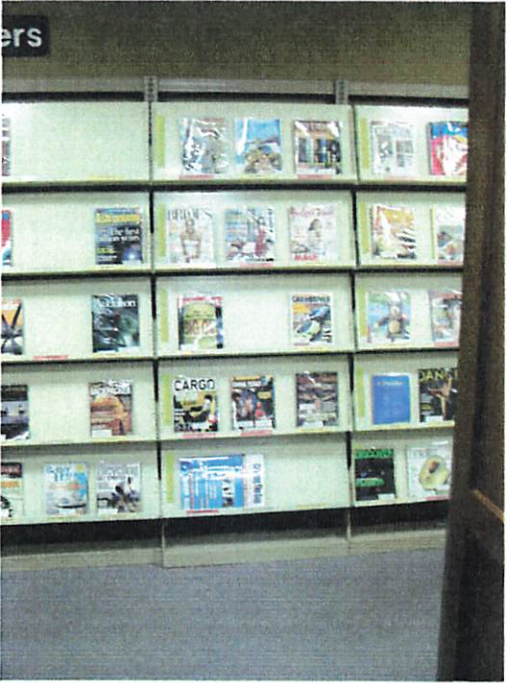
<p><i>San Marino</i></p> <p>Location: First floor level.</p> <p>Noncomplying Condition: Magazine and card catalogs exceed 54 inches maximum reach condition.</p> <p>Effort to Correct: Minor</p> <p>Cost to Correct: \$\$ to \$\$\$</p> <p>Suggested Corrective Action: Install complying displays and catalogs.</p>	<p><u>ADAAG</u> 8.4</p>
<p>14.</p> <p>No Photograph</p>	<p>Door closers should not require more than 5 pounds to operate except that fire-rated door assemblies may require not more than 15 pounds of force to operate. All doors not in compliance should be adjusted or have the closer replaced.</p>	<p><u>CBC</u> 2-1133B.2.5 2-1133B.2.5.1 2-1133B.2.5.2</p> <p><u>ADAAG</u> 4.13.10 4.13.11</p>

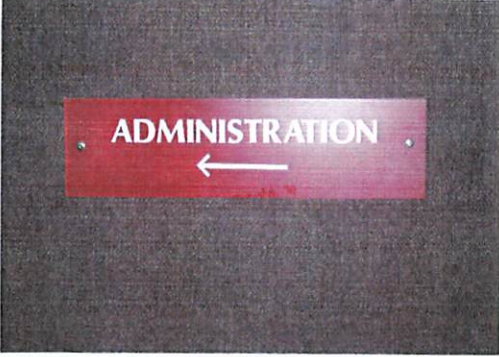
15.

<p>Inadequate existing exterior and interior signage. Signage (including tactile information) which identifies directs or gives information about accessible elements and features should be installed as appropriate to the element or feature.</p>	<p><u>CBC</u> 2-1117B.5 2-1127B.3 (See Appendix B)</p> <p><u>ADAAG</u> Section 4.30</p>

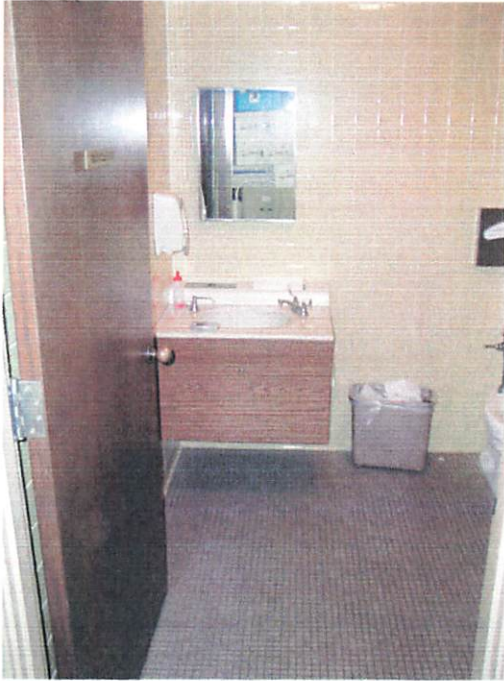
Image	Description	Associated Code Section ¹
<p>18.</p>

<p>Location: Second floor staff restroom.</p> <p>Noncomplying Condition: Cabinet mounted lavatory. Soap dispenser is not located in an accessible location. Mirror above sink is inadequate. Paper towel dispenser may be located in an inaccessible location. Door knob is noncompliant.</p> <p>Effort to Correct: Minor</p> <p>Cost to Correct: \$\$</p> <p>Suggested Corrective Action: Replace the cabinet mounted lavatory with a complying lavatory. Relocate the soap dispenser and paper towel dispenser. Add a second, complying mirror. Replace door knob with complying lever door hardware. Wrap hot water and drain piping.</p>	<p style="text-align: center;"><u>CBC</u> 2-1115B.2.1.2.1 2-1115B.9.2 2-1115B.9.1(2) 2-1133B.2.5.2</p> <p style="text-align: center;"><u>ADAAG</u> 4.13.9 4.19.2</p>

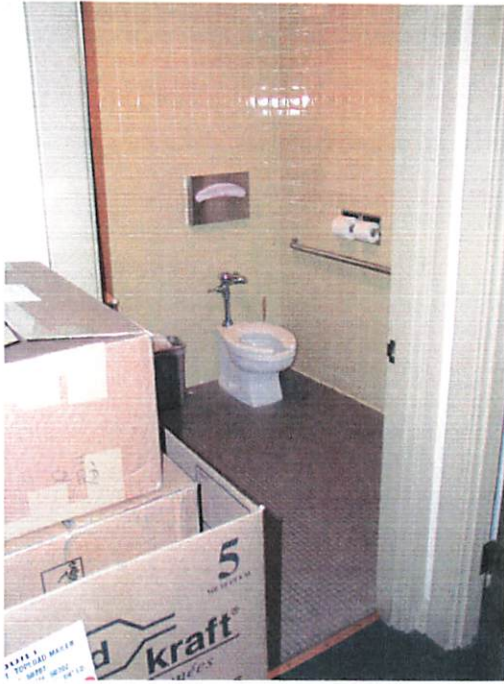
19.

Location: Second floor staff restroom.

Noncomplying Condition: Toilet seat is too low. Grab bar is missing from the back wall. Toilet tissue dispenser is too high above the floor. Paper toilet seat cover dispenser is mounted in an inaccessible location.

Suggested Corrective Action: Replace the toilet with a complying toilet. Install missing grab bar. Relocate toilet tissue and paper toilet seat cover dispensers.

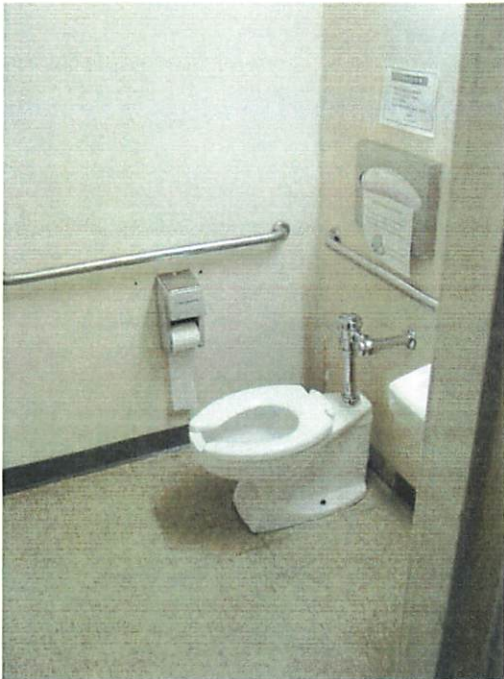
20.

Location: First floor staff restroom.

Noncomplying Condition: Toilet is mounted too far away from the wall. Paper toilet seat cover dispenser is located in an inaccessible location. (See also Item No. 21 for related noncomplying conditions.)

Suggested Corrective Action: Replace toilet with complying toilet mounted in the correct location. Relocate paper toilet seat cover dispenser to an accessible location.

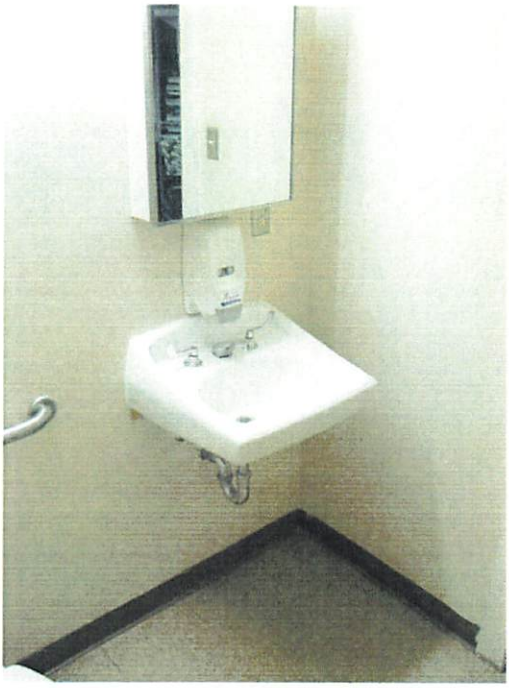
<p>21.</p>

<p>Location: First floor staff restroom.</p> <p>Noncomplying Condition: Lavatory is mounted too close to the toilet. Hot water and drain lines not wrapped. (See also Item No. 20 for related noncomplying conditions.)</p> <p>Effort to Correct: Significant to major.</p> <p>Cost to Correct: \$\$\$\$</p> <p>Suggested Corrective Action: Relocate lavatory to a complying location. (This may require that the room be enlarged to provide complying clear space requirements.) Wrap the hot water and drain lines.</p>	<p><u>CBC</u> 2-1115B.7.2 2-1115B.2.1.2.2</p> <p><u>ADAAG</u> 4.16.2 4.19.4</p>
<p>22.</p> <p style="text-align: center;">No Photograph</p>	<p>Location: First floor staff restroom.</p> <p>Noncomplying Condition: Light switch is mounted too high, and the door has a round door knob.</p> <p>Effort to Correct: Minor</p> <p>Cost to Correct: \$ to \$\$</p> <p>Suggested Corrective Action: Relocate the light switch to an accessible location.</p>	<p><u>CBC</u> 2-1118B.5 2-1118B.62- 1133B.2.5.2</p> <p><u>ADAAG</u> 4.13.9 4.27.3</p>

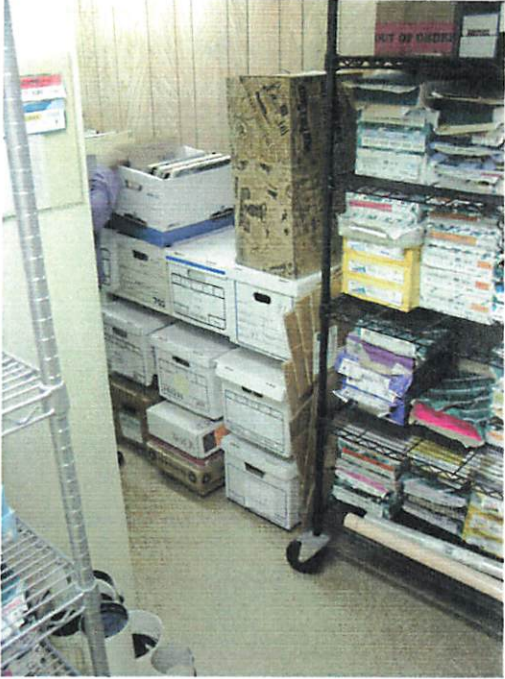
<p>23.</p>

<p>Location: Access hallway to first floor staff bathroom.</p> <p>Noncomplying Condition: Required width for path of travel.</p> <p>Effort to Correct: Negligible</p> <p>Cost to Correct: \$</p> <p>Suggested Corrective Action: Relocate storage materials to another location.</p>	<p><u>CBC</u> 2-1105B.3.6(1)</p> <p><u>ADAAG</u> 4.2.1</p>
<p>24.</p>  	<p>Location: Men's public restroom on the first floor.</p> <p>Noncomplying Condition: The lower urinal is too high above the floor and does not project far enough from the wall.</p> <p>Effort to Correct: Significant (See also potential location impact from item number 25.)</p> <p>Cost to Correct: \$\$\$ to \$\$\$\$</p> <p>Suggested Corrective Action: Replace the urinal with a complying urinal mounted at the correct height.</p>	<p><u>CBC</u> 2-1115B.2.1.1.1</p> <p><u>ADAAG</u> 4.18.2</p>

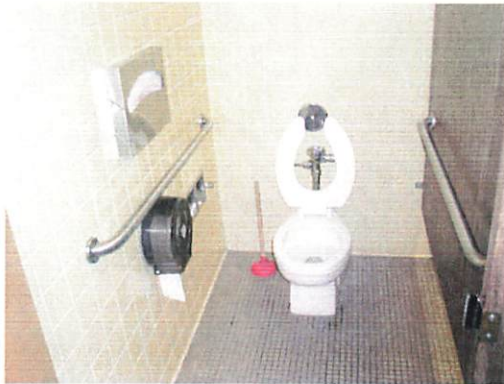
25.

Noncomplying Condition: Toilet is too low. Toilet is located too far from the tile wall and too close to the partition wall. Paper toilet seat cover dispenser is located too high above the floor.

Effort to Correct: Significant to Major.

Cost to Correct: \$\$\$\$

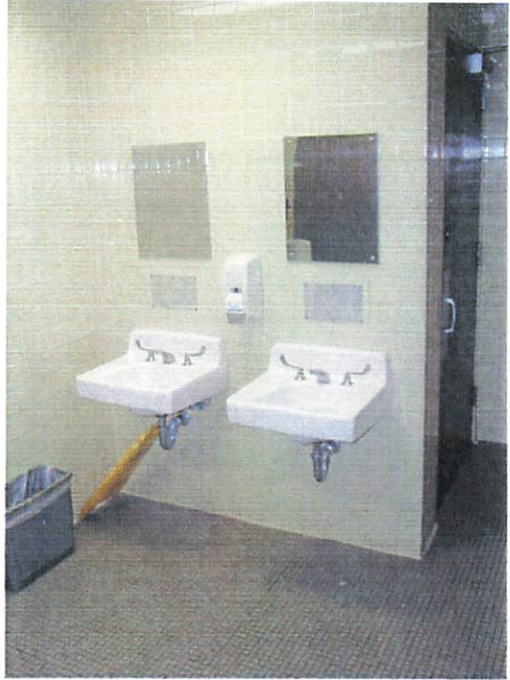
<p>26.</p>

<p>Location: Men's public restroom on the first floor.</p> <p>Noncomplying Condition: Lavatories are mounted too low. Hot water and drain piping is not wrapped. Metal mirrors are mounted in an inaccessible location.</p> <p>Effort to Correct: Minor</p> <p>Cost to Correct: \$</p> <p>Suggested Corrective Action: Raise at least one lavatory to the correct height.</p>	<p><u>CBC</u> 2-1115B.2.1.2.1 2-1115B.2.1.2.2 2-1115B.9.1(2)</p> <p><u>ADAAG</u> 4.19.2 4.19.4 4.19.6</p>
<p>27.</p>

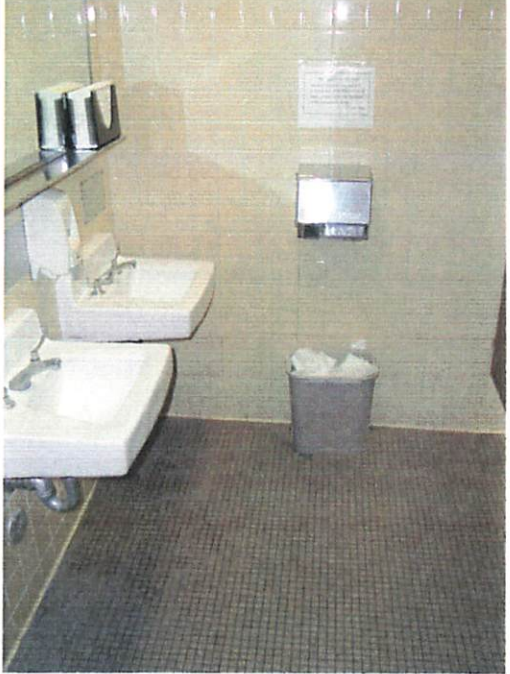
<p>Location: Women's public restroom on the first floor.</p> <p>Noncomplying Condition: Lavatories are mounted too low. Hot water and drain piping is not wrapped. Mirror is mounted in an inaccessible location.</p> <p>Effort to Correct: Minor</p> <p>Cost to Correct: \$\$</p> <p>Suggested Corrective Action: Raise at least one lavatory to the correct height and install a second, complying mirror.</p>	<p><u>CBC</u> 2-1115B.2.1.2.1 2-1115B.2.1.2.2 2-1115B.9.1(2)</p> <p><u>ADAAG</u> 4.19.2 4.19.4 4.19.6</p>

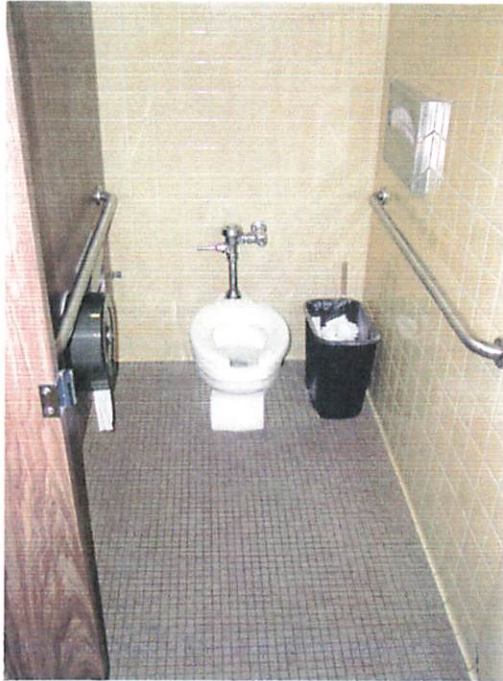
28.

Location: Women's public restroom on the first floor.

Noncomplying Condition: Toilet is too low. Toilet is located too far from the tile wall and too close to the partition wall. Paper toilet seat cover dispenser is located too high above the floor.

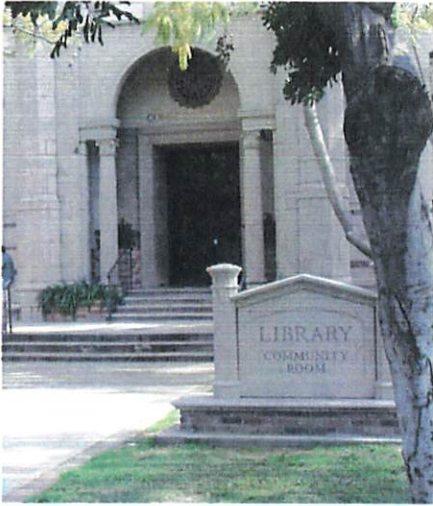
Image	Description	Associated Code Section ¹
<p>29.</p>

<p>Location: Entrance to Community Room.</p> <p>Noncomplying Condition: No vertical access to this facility for the disabled during hours when the Library is not open. No complying handrails. No visual striping on the stair treads.</p> <p>Effort to Correct: Significant to Major.</p> <p>Cost to Correct: \$\$\$ to \$\$\$\$</p> <p>Suggested Corrective Action: <i>Option No. 1:</i> Utilize the Community Room only during times when the Library elevator is available. Add complying handrails and stair tread striping to the stair treads.</p> <p><i>Option No. 2:</i> Provide vertical access by ramp or lift. Install complying handrails and add visual striping to the stairs.</p>	<p style="text-align: center;"><u>CBC</u> 2-1103B.1 2-1114B.1.2 2-1133B.4.2.1 2-1133B.4.2.2 2-1133B.4.2.6.1 2-1133B.4.2.6.2 2-1133B.4.4</p> <p style="text-align: center;"><u>ADAAG</u> 4.1.2 4.9.4</p> <p style="text-align: center;"><u>CBC</u> <u>Tactile Exit Signage</u> <u>Requirements</u>² 2-1003.2.8.6 2-1003.2.8.6.1</p>

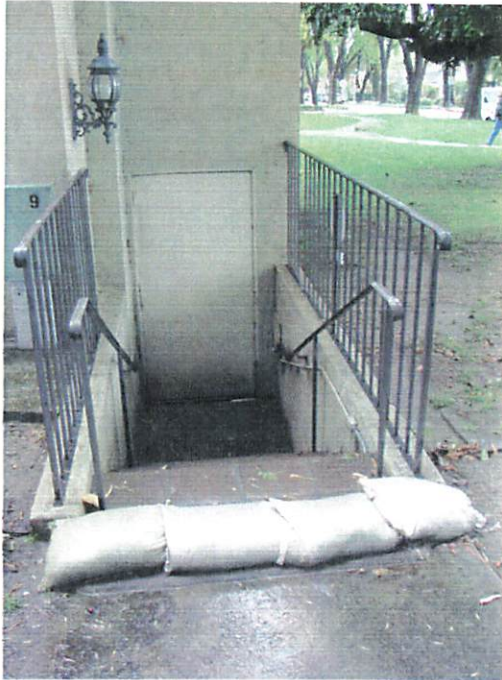
30.

Location: Stairway serving first floor on northwest side of the Library.

Noncomplying Condition: Handrail cross-section, handrail extensions are missing, no visual stair striping.

Suggested Corrective Action: Replace the handrails with complying handrails, and install visual striping on the stair treads.

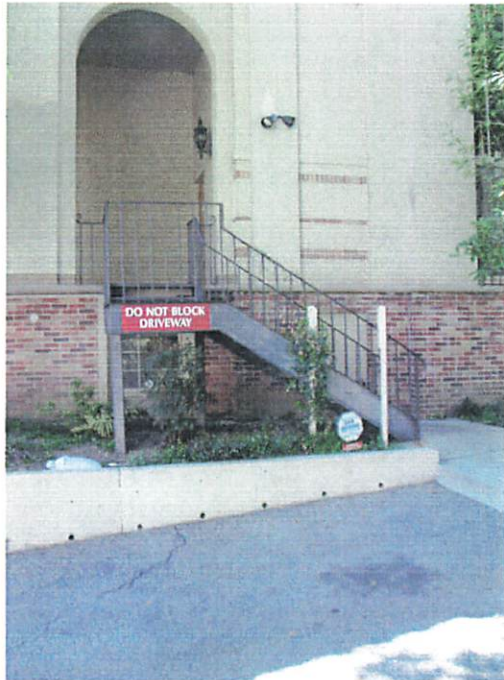
31.

Location: East side of the Library serving the second floor level.

Noncomplying Condition: Handrails and lack of visual striping on the stair treads. (See also Item Numbers 32 and 33 for related noncomplying information.)

Option No. 1: Remove and replace the stairs with either a ramp, a stair/ramp combination, or a stair/vertical lift combination.

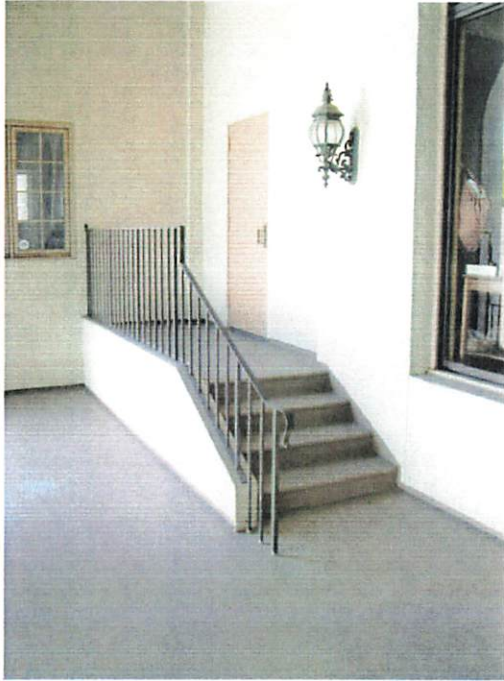
32.

Location: South end of second floor balcony areas on the east and west sides of the Library.

Noncomplying Condition: Lack of complying vertical access to balconies from either the second floor level of the Library or from exterior grade level. As with all other exterior stairs, the handrail is noncomplying and the stair treads lack visual striping. (See also Item Numbers 31 and 33 for related noncomplying information.)

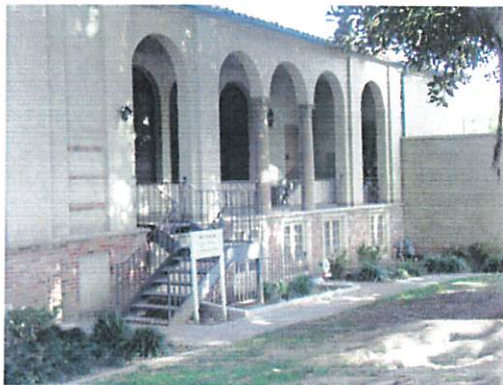
Noncomplying Condition: Handrails and lack of visual striping on the stair treads. (See also Item Numbers 31 and 32 for related noncomplying information.)

Option No. 1: Remove and replace the stairs with either a ramp, a stair/ramp combination, or a stair/vertical lift combination.

Option No. 2: Convert exit doors serving the balcony area to alarmed panic hardware, and use for emergency exiting only. (This option prevents the Conference room from being used during hours when the Library is not open for business.) (See also Item Numbers 18 and 19 for related noncomplying information.) Install complying handrails and visual striping on the stair treads.

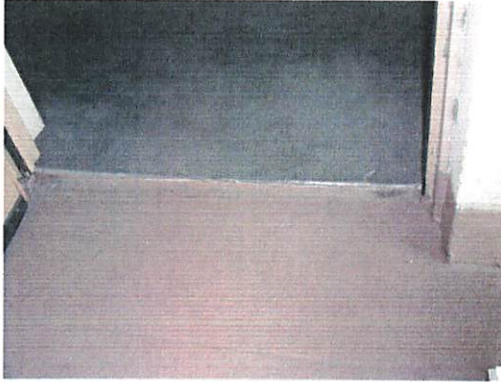
34.

Location: Photo is taken at the exit door from the Community Room to the exterior balcony on the west side of the Library. Similar noncomplying door threshold conditions occur at various exterior doors throughout the Library.

Noncomplying Condition: Vertical difference in height between the top of threshold and the lowest floor surface exceeds allowable requirements.

Cost to Correct: \$ to \$\$ depending on actual door condition.

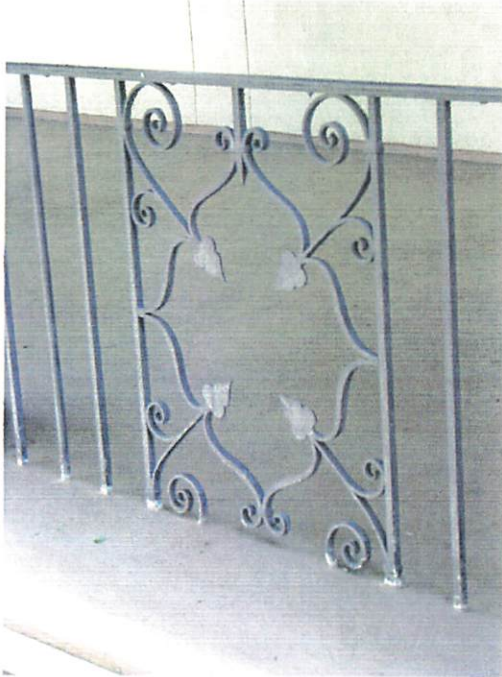
35.

Location: Guardrails at balconies on the east and west side of the Library.

Noncomplying Condition: Not a noncomplying disabled access condition, but does violate the basic guardrail conditions because a small child could easily fit through the opening and fall off of the balcony. Additionally, existing guardrails are lower than current Code requirements. Although not retroactive, the City may want to consider correcting both the guardrail opening and height conditions.

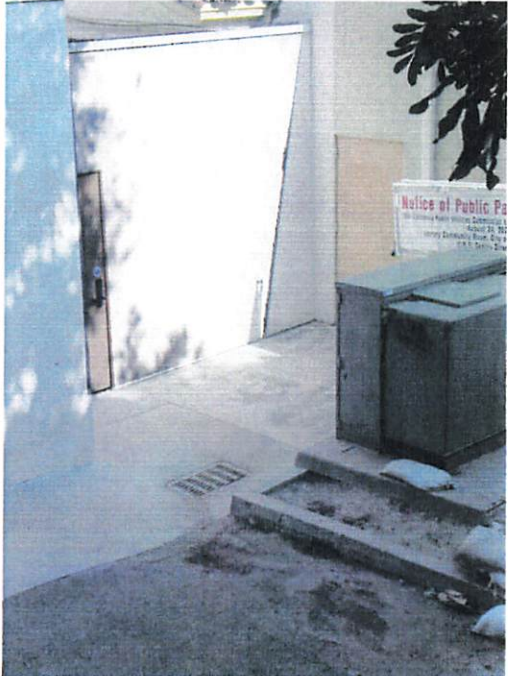
Image	Description	Associated Code Section ¹
36.

<p>Location: North side of both the Library and the Senior Center, between the two buildings.</p> <p>Noncomplying Condition: Location of storm water catch basin directly in the exiting path of travel serving exterior doors for both the Library and the Senior Center.</p> <p>Effort to Correct: Significant to major.</p> <p>Cost to Correct: \$\$\$ to \$\$\$\$</p> <p>Suggested Corrective Action: At a minimum, raise the top of catch basin and surrounding pavement to create an exit path with no more than 2% cross slope in any direction.</p>	<p><u>CBC</u> 2-1124B.1 2-1124B.2 2-1124B.4</p> <p><u>ADAAG</u> 4.3.7 4.3.8 4.5.1 4.5.2 4.13.8</p>

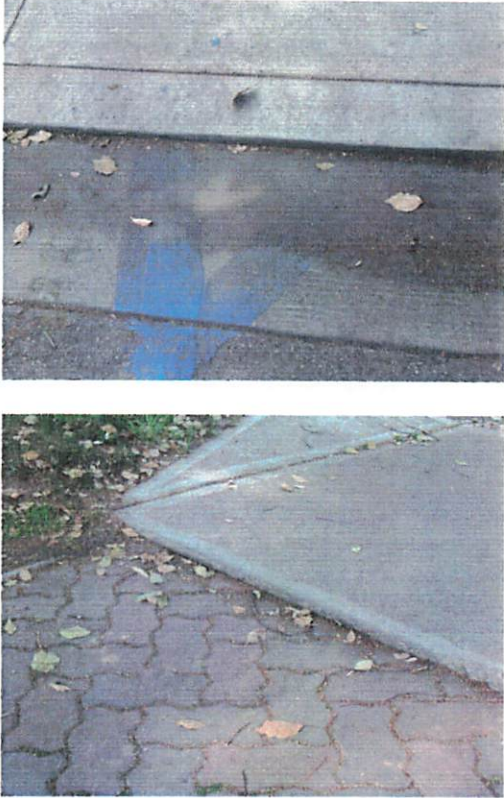
<p>37.</p>

<p>Location: Walkways surrounding both the Library and the Senior Center.</p> <p>Noncomplying Condition: Hard surfaces have shifted over time to create vertical differences in the surfaces which exceed allowable requirements for paths serving the disabled.</p> <p>Effort to Correct: Depending on actual conditions and method of correction: Minor to Significant.</p> <p>Cost to Correct: \$\$ to \$\$\$</p> <p>Suggested Corrective Action: Eliminate the noncomplying condition by grinding and/or releveling the surfaces as appropriate.</p>	<p><u>CBC</u> 2-1124B.1 2-1124B.2</p> <p><u>ADAAG</u> 4.5.1 4.5.2</p>
<p>38.</p>
