Subject: ADA Assessment of City Library and Senior Center

**City of South Pasadena
Disabled Access Assessment
for the
Library and Senior Center**

Prepared by
Transtech Engineers, Inc.
April 21, 2006

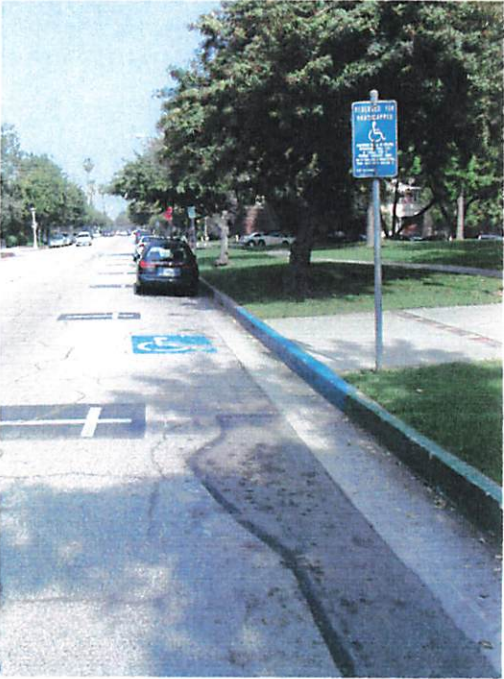
<p>Location: On El Centro, west of Fairview.</p> <p>Noncomplying Condition: No loading zone and no curb ramp.</p> <p>Effort to Correct: Significant.</p> <p>Cost to Correct: \$\$\$ to \$\$\$\$</p> <p>Suggested Corrective Action: Remove and relocate to an appropriate location.</p>	<p><u>CBC</u> 2-1114B.1.2 2-1129B.4.2 2-1127B.5 No. 8 2-1129B.4.4 (See Appendix C)</p> <p><u>ADAAG</u> 4.6.3 4.6.6 4.7</p>

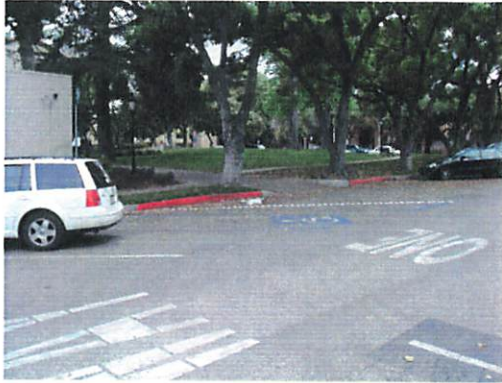
39.

Location: Various locations surrounding the Senior Center and Library facility.

Noncomplying Condition: No van accessible parking is provided. Curb ramps lack detectable warnings. Parking surface slope exceeds allowable.

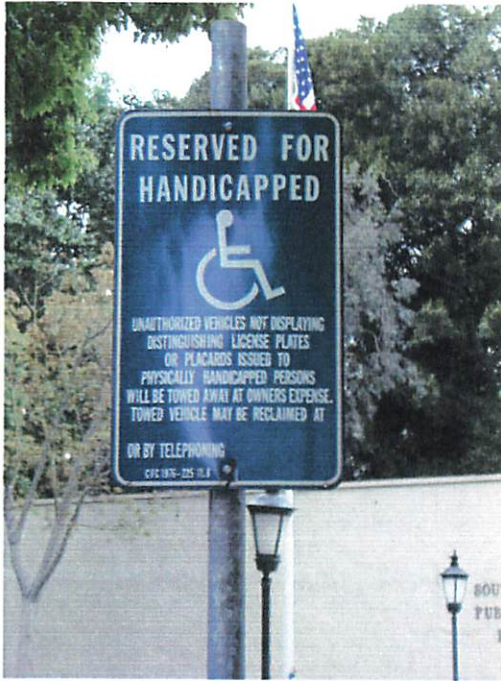
42.

Location: Disabled access parking spaces serving the Senior Center and Library.

Noncomplying Condition: Required phone number is not provided in the event that a car is towed for violating disabled access parking requirements.
