FACILITY CONDITION ASSESSMENT

SOUTH PASADENA PUBLIC LIBRARY

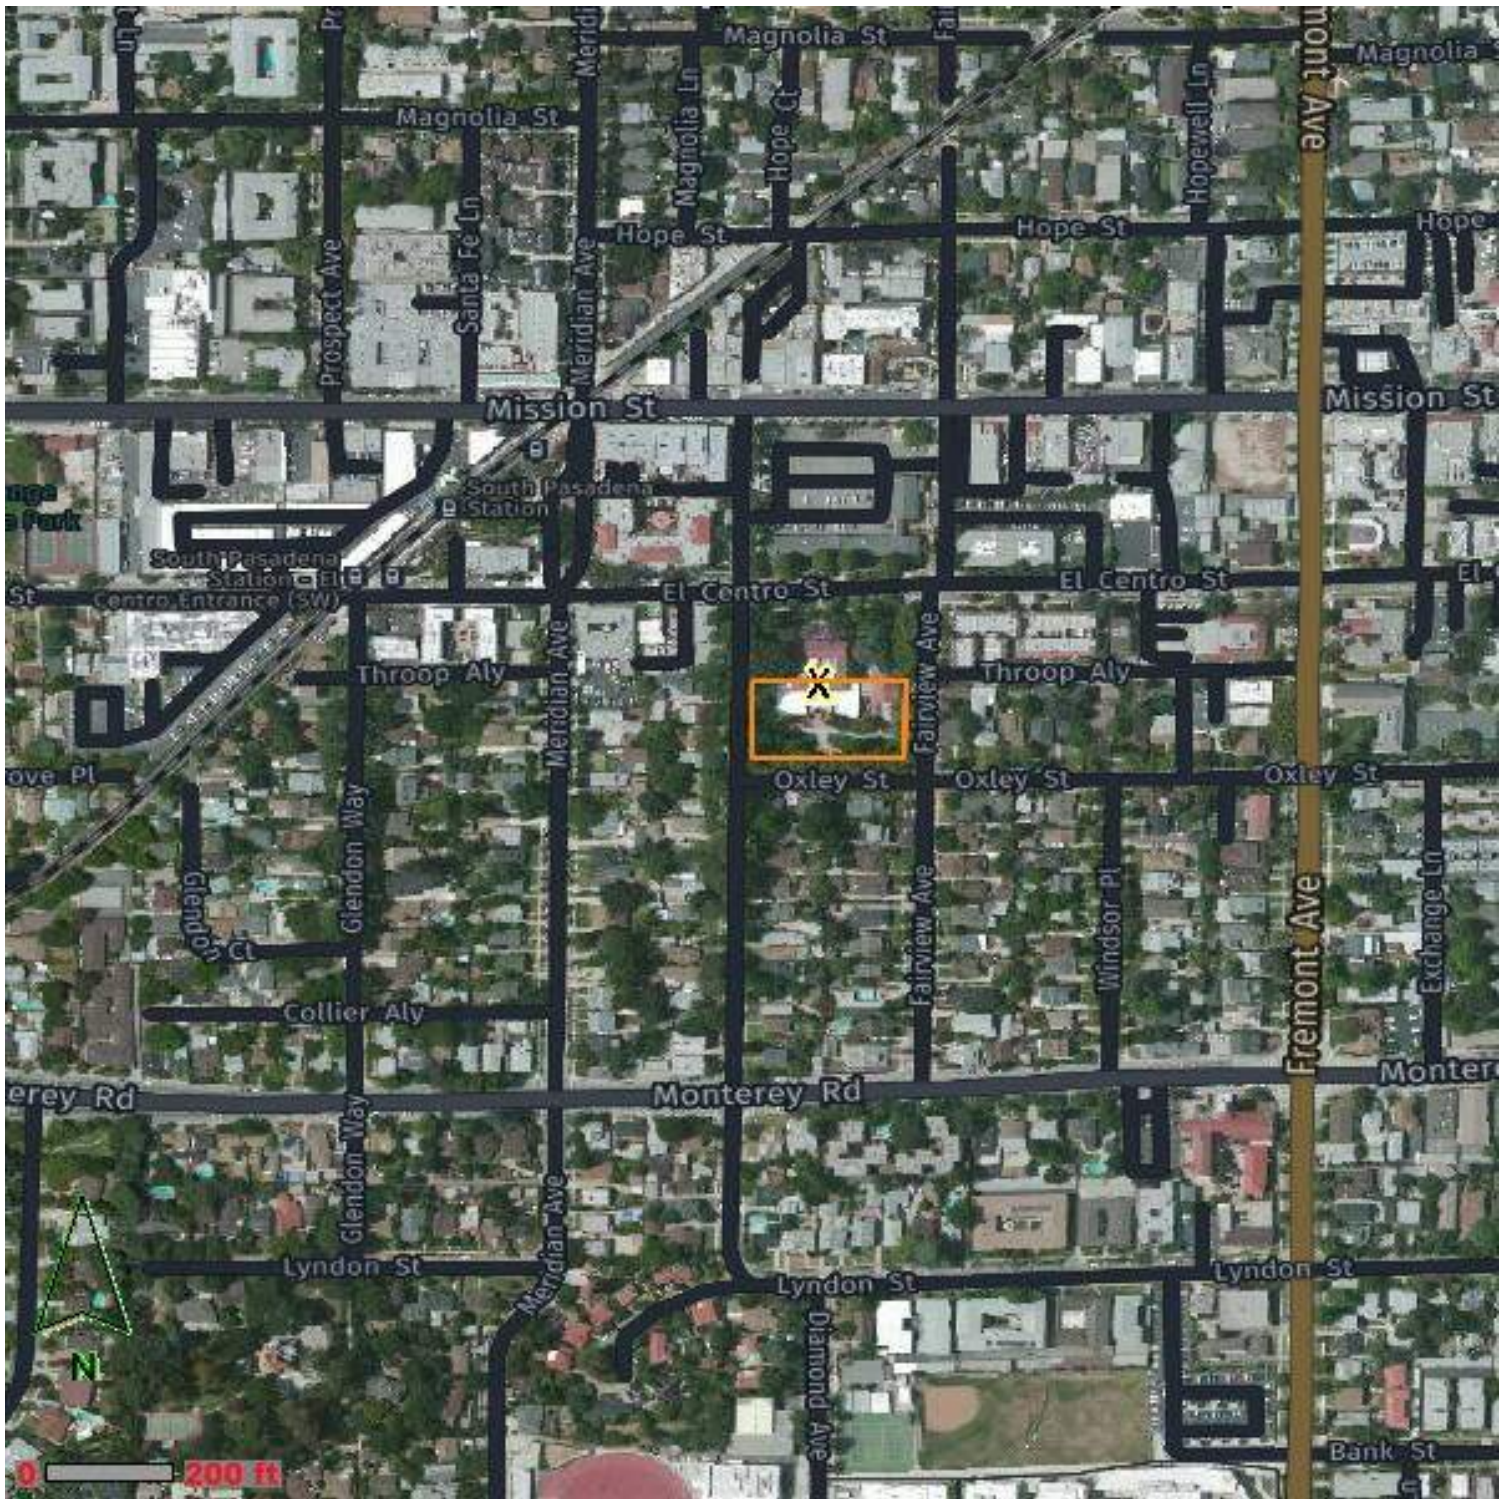
**Flood Zones
Legend**

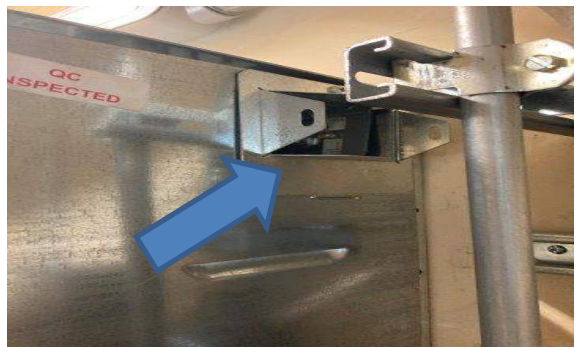
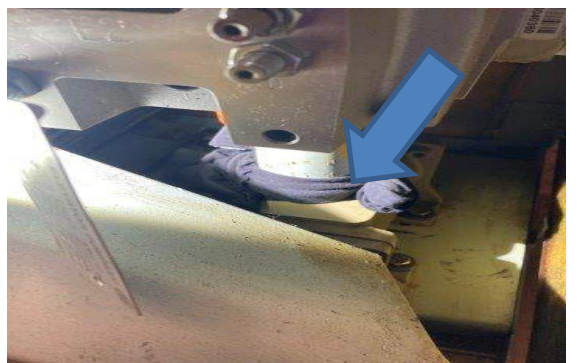
Hydraulic tank hole (top) and Victaulic leak (bottom)

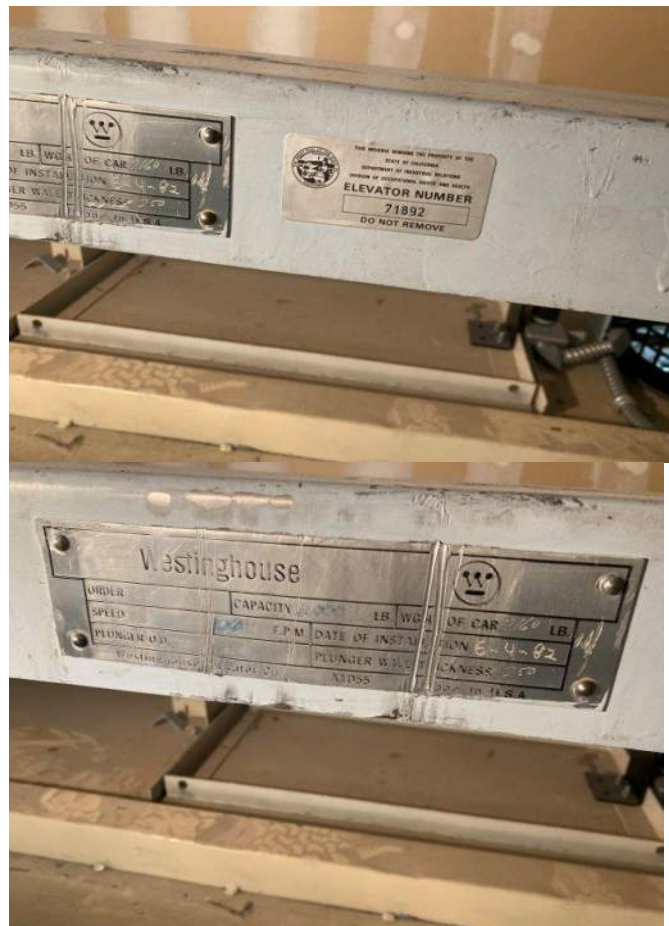
Westinghouse crosshead data tag. 06/04/1982. State # 71892

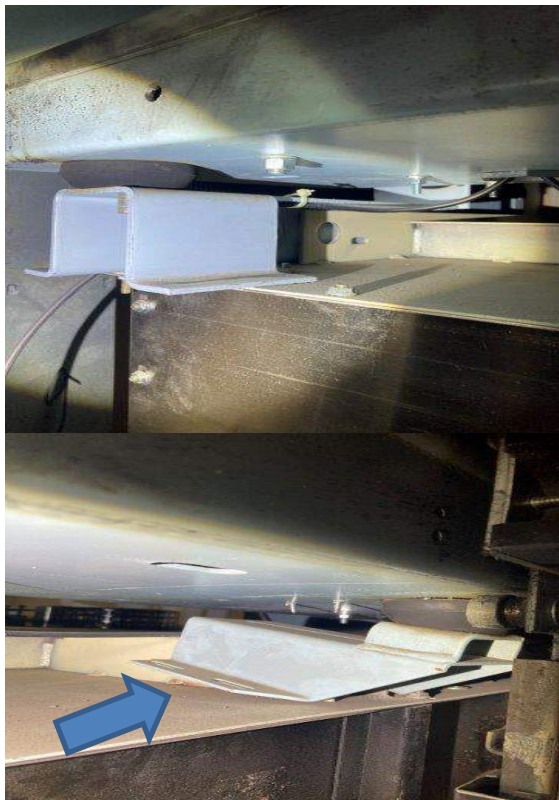
Car top door operator isolation bracket damage

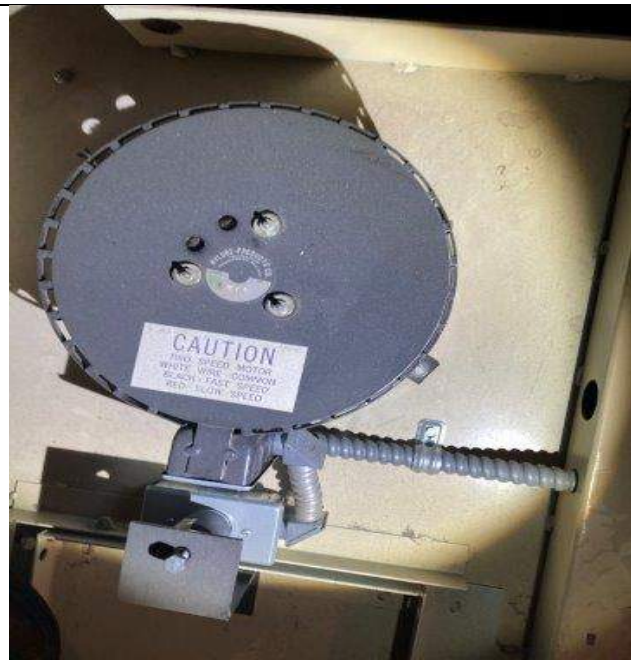
Elevator car top fan and emergency exit

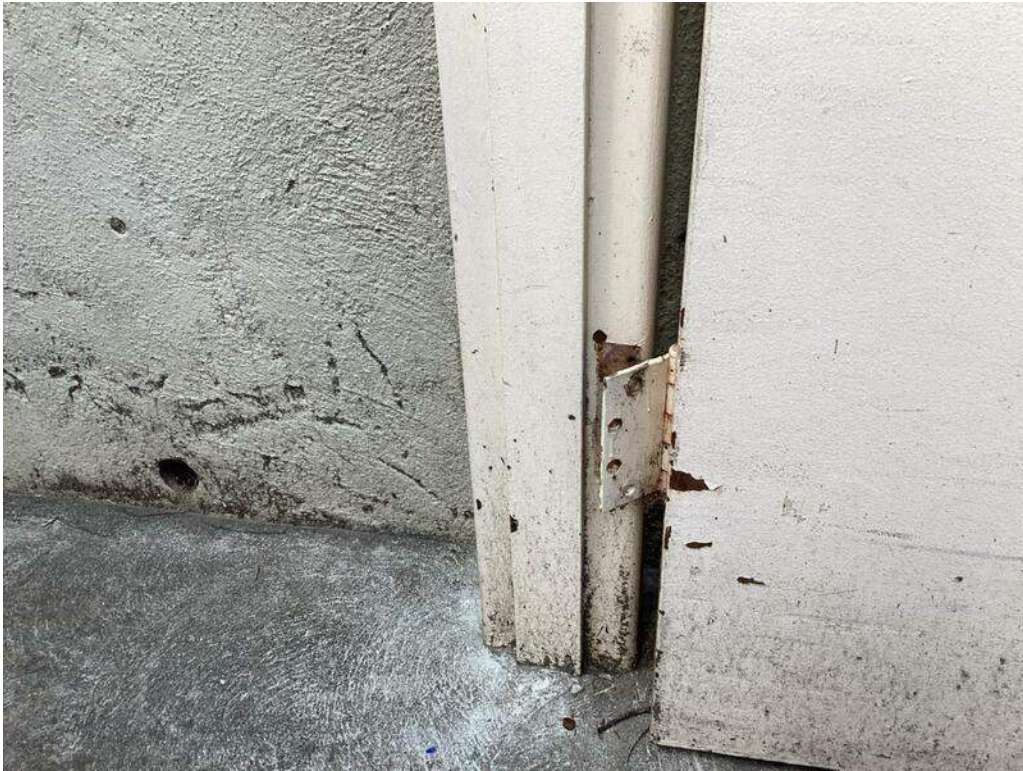
17 - Broken hinge at the service yard gate.

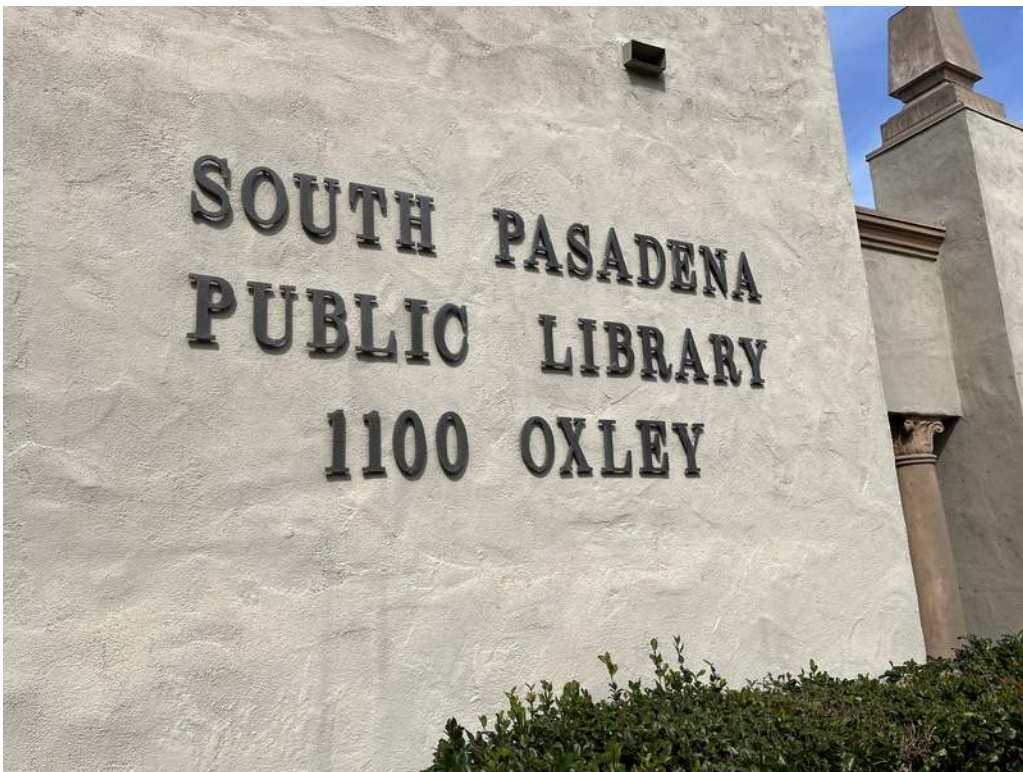
18 - Building-mounted identification and address signage at the south building entry.

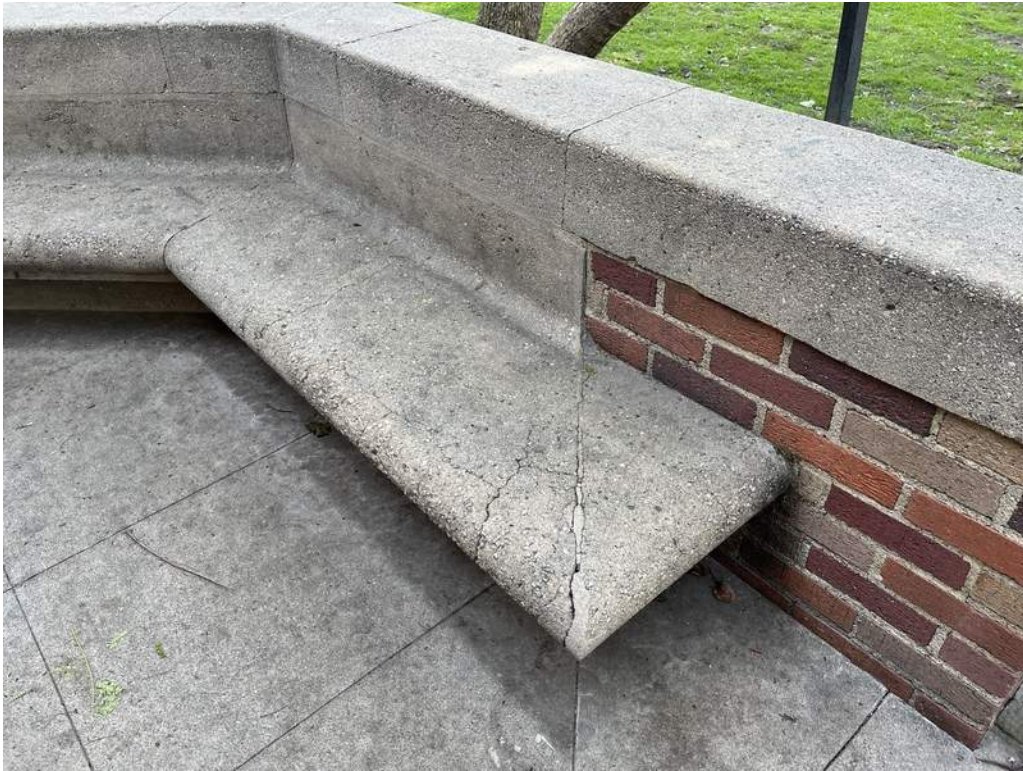
21 - Cracked concrete bench at the Community Room entrance.

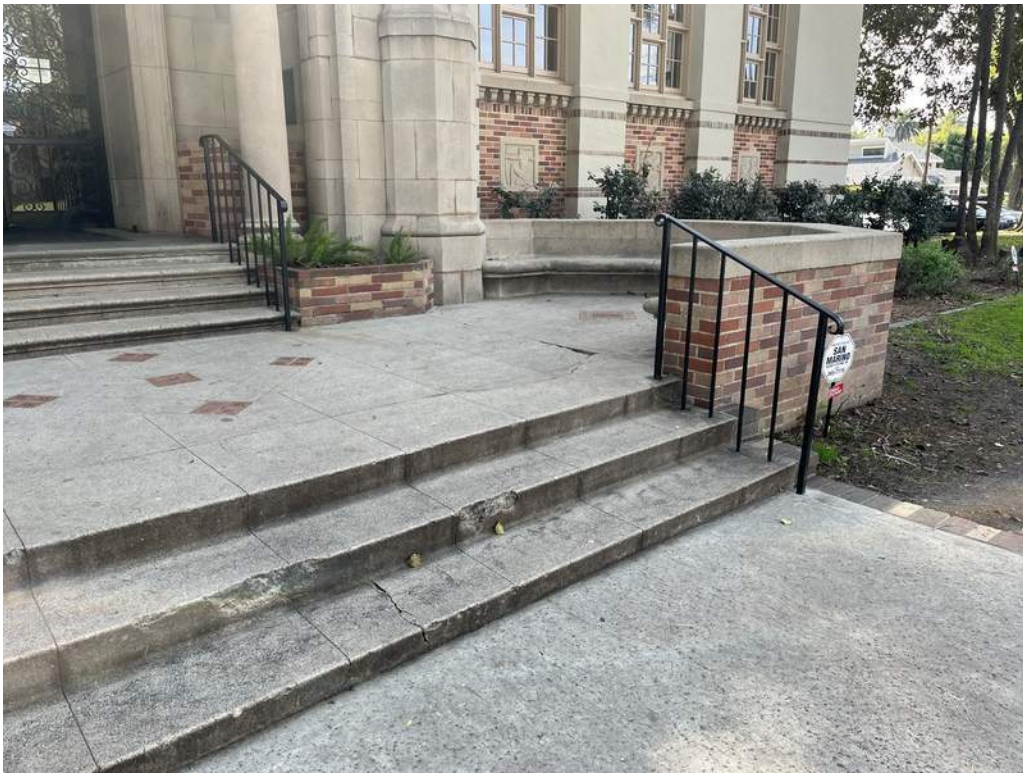
22 - Concrete seating area is located at the entrance to the Community Room.

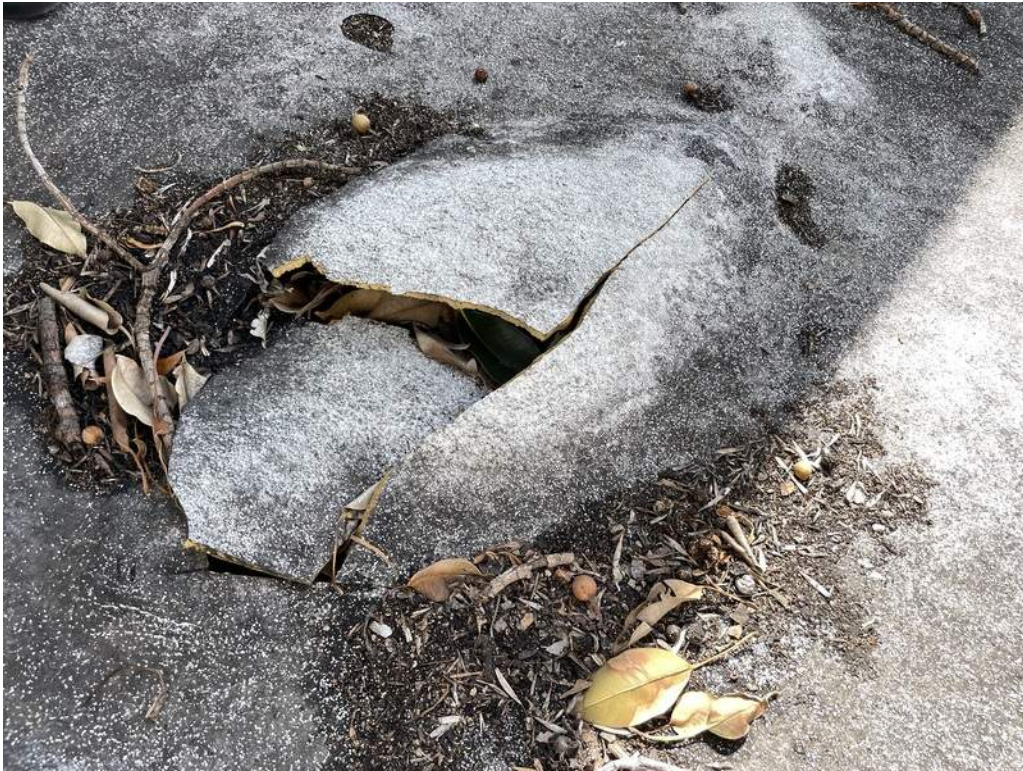
31 - Large ruptured blister in the spray foam roofing membrane.

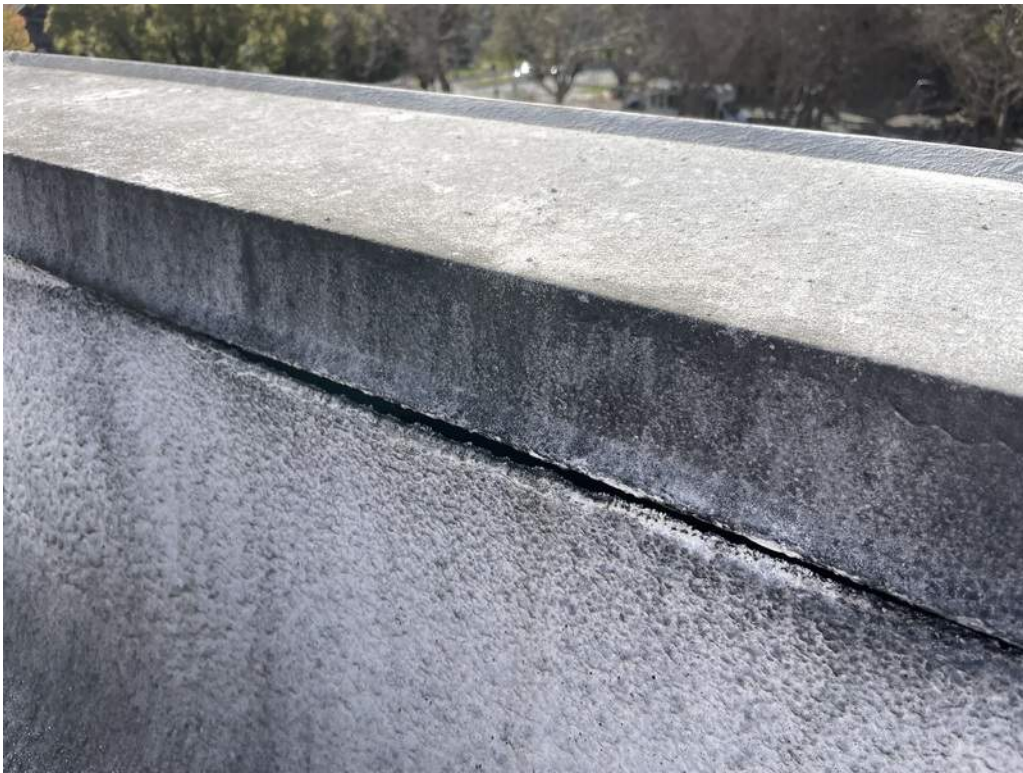
32 - The roofing termination at the parapet is separating providing a possible path for moisture intrusion.

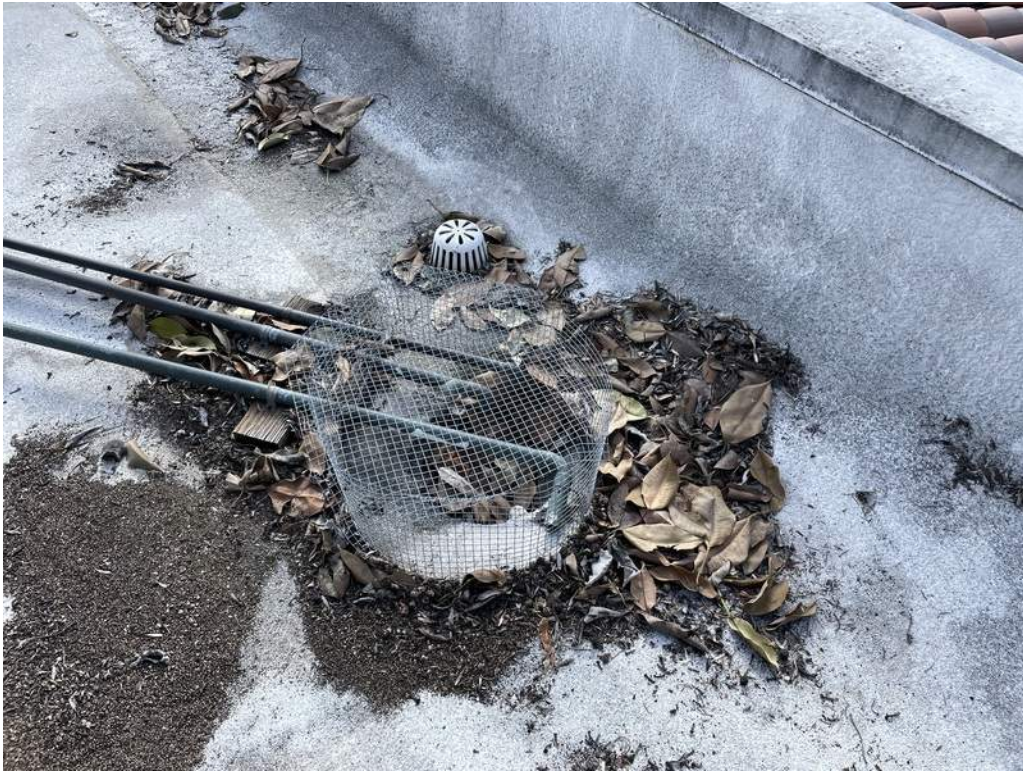
33 - Internal low-slope roof drain and overflow. Debris build-up noted.

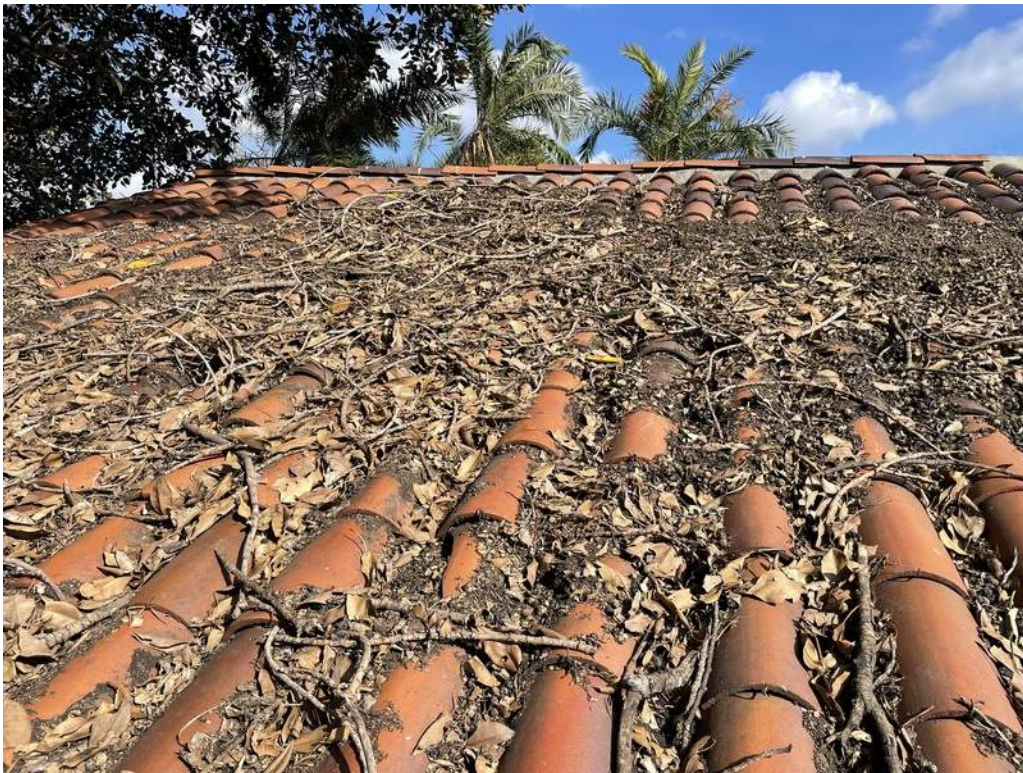
34 - Debris build-up on the clay tile roof.

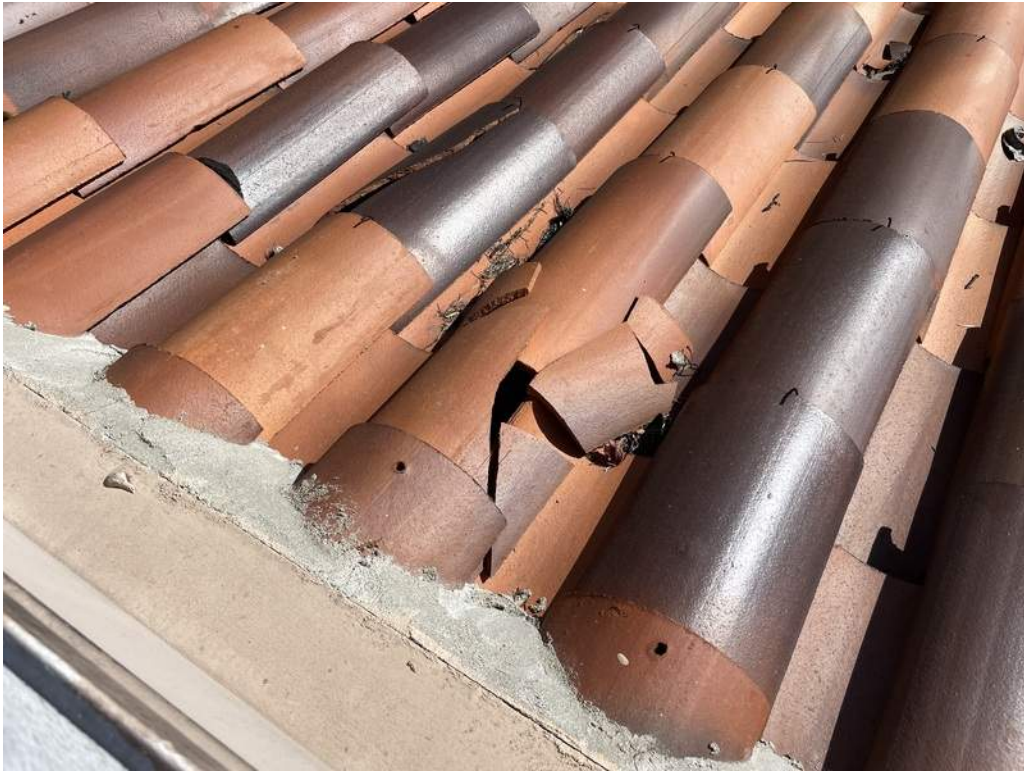
35 - Damaged clay tiles.

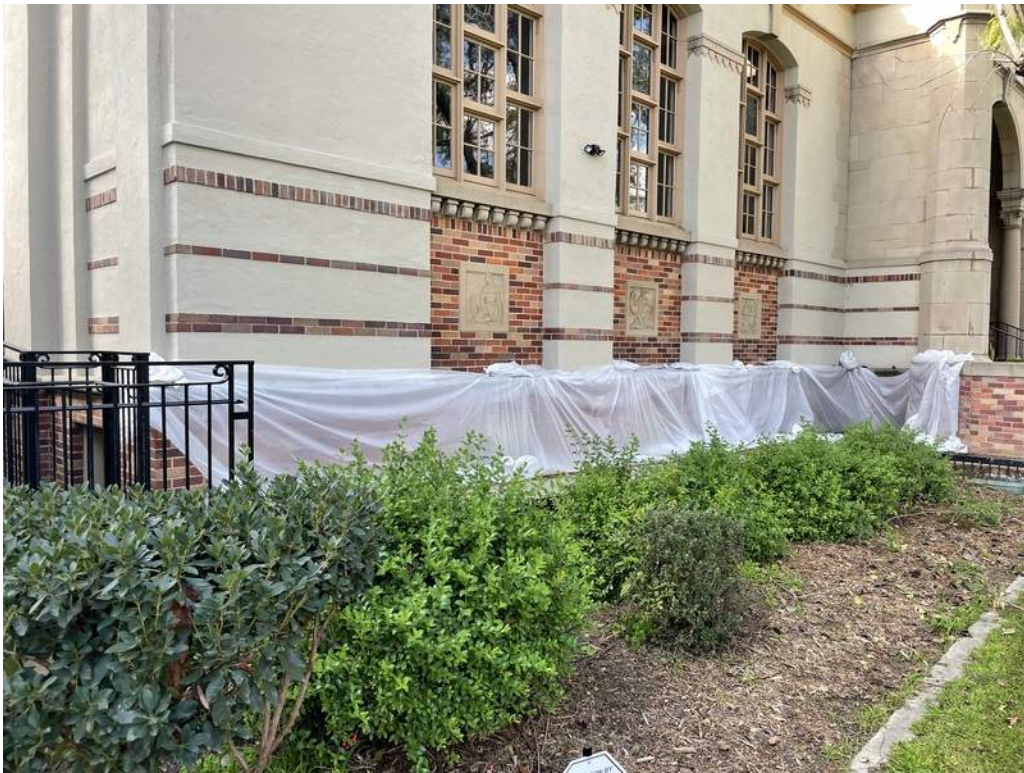
36 - Northeast corner of building with temporary plastic sheeting to reduce water infiltration into the basement.

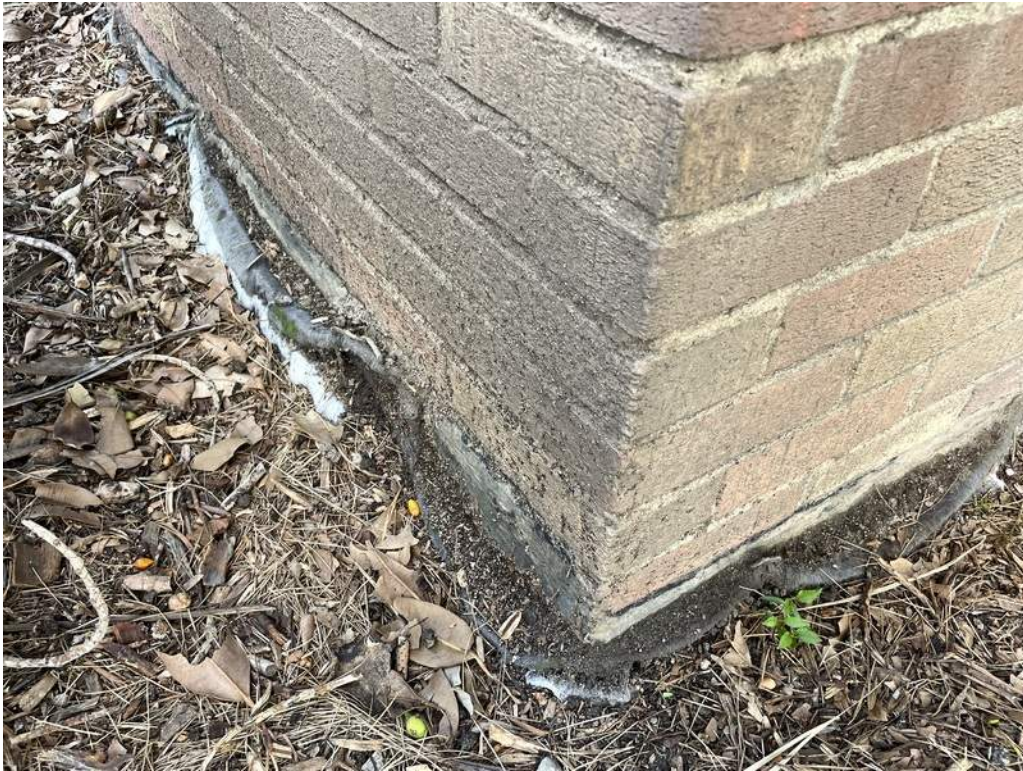
37 - The visible edge of the below-grade waterproofing is deteriorated and not provided with termination bar and counter flashing.

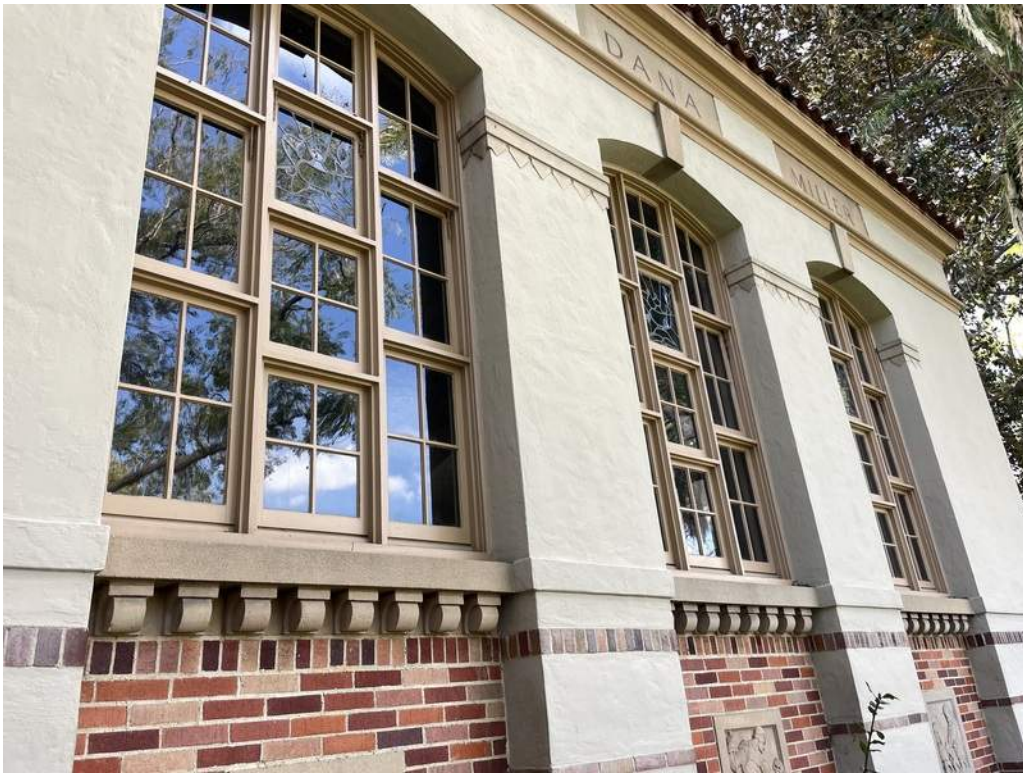
38 - Original wooden windows set into exterior cement plaster wall and accents of brick and stone.

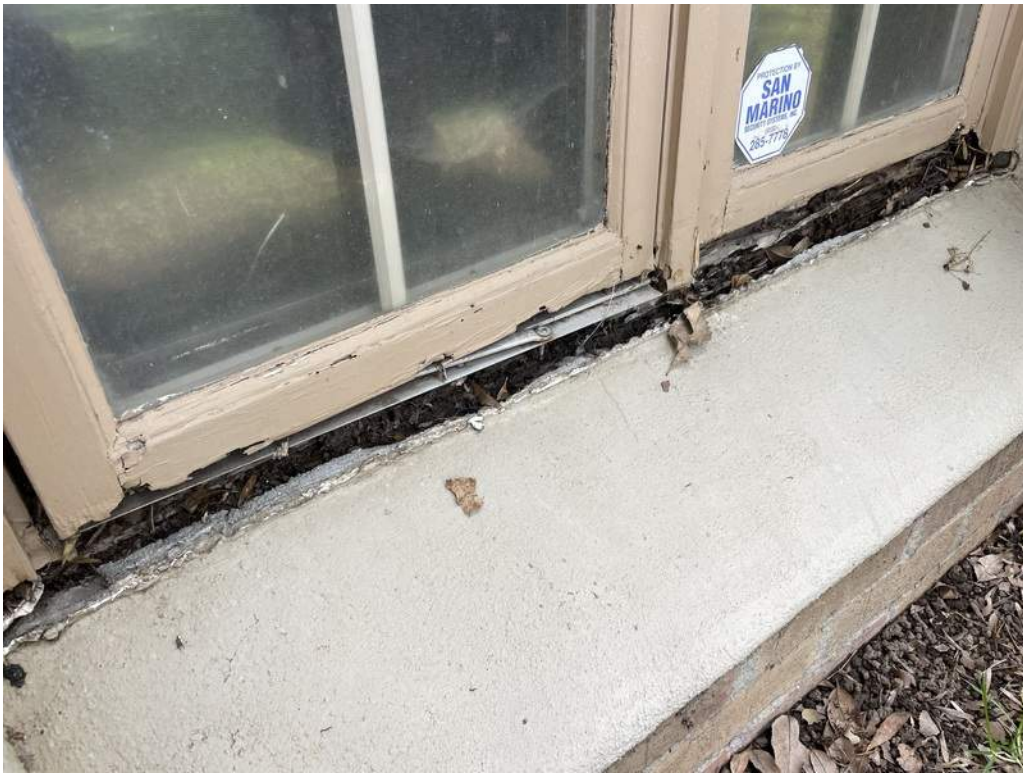
39 - Rotted and deteriorated window sill.

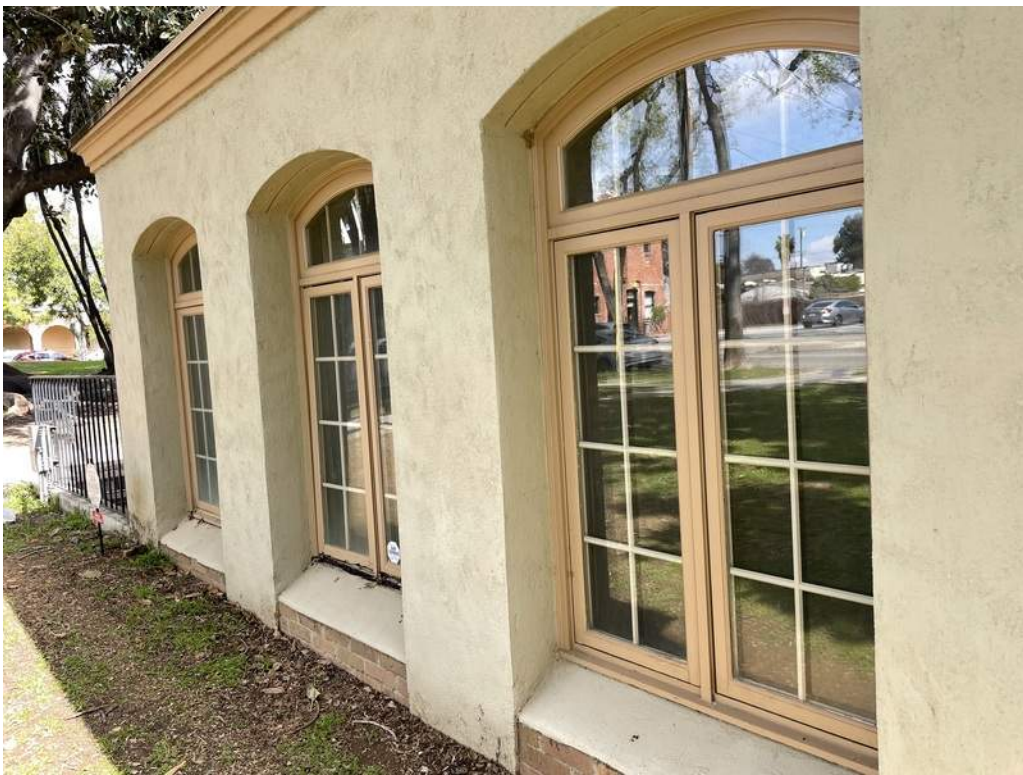
40 - Wooden windows set into exterior cement plaster wall.

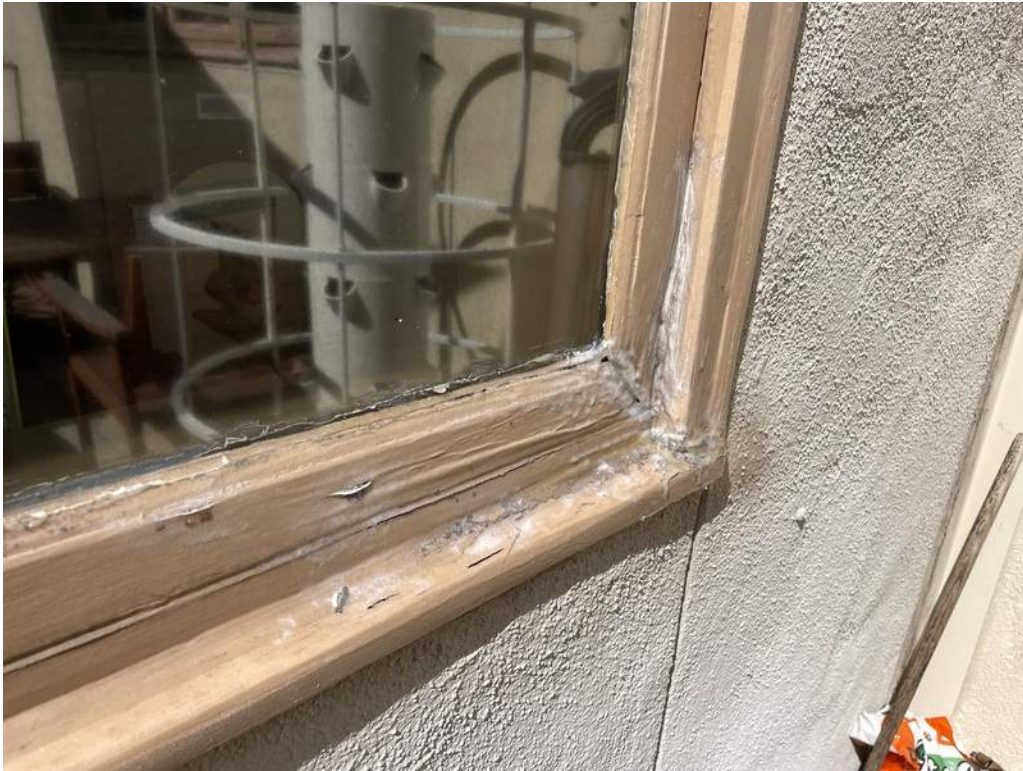
43 - Evidence of wood rot at the window frame; the material is soft and brittle. Film-forming sealer temporary repair noted.

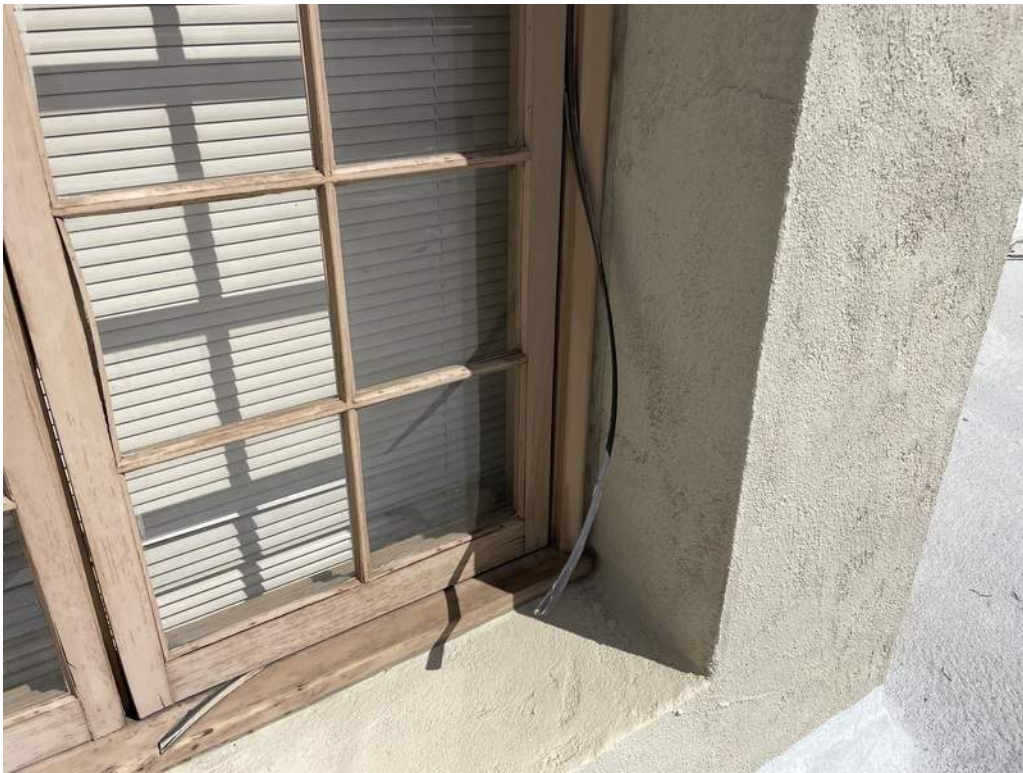
44 - Deteriorated and warped window with failed gaskets and paint.

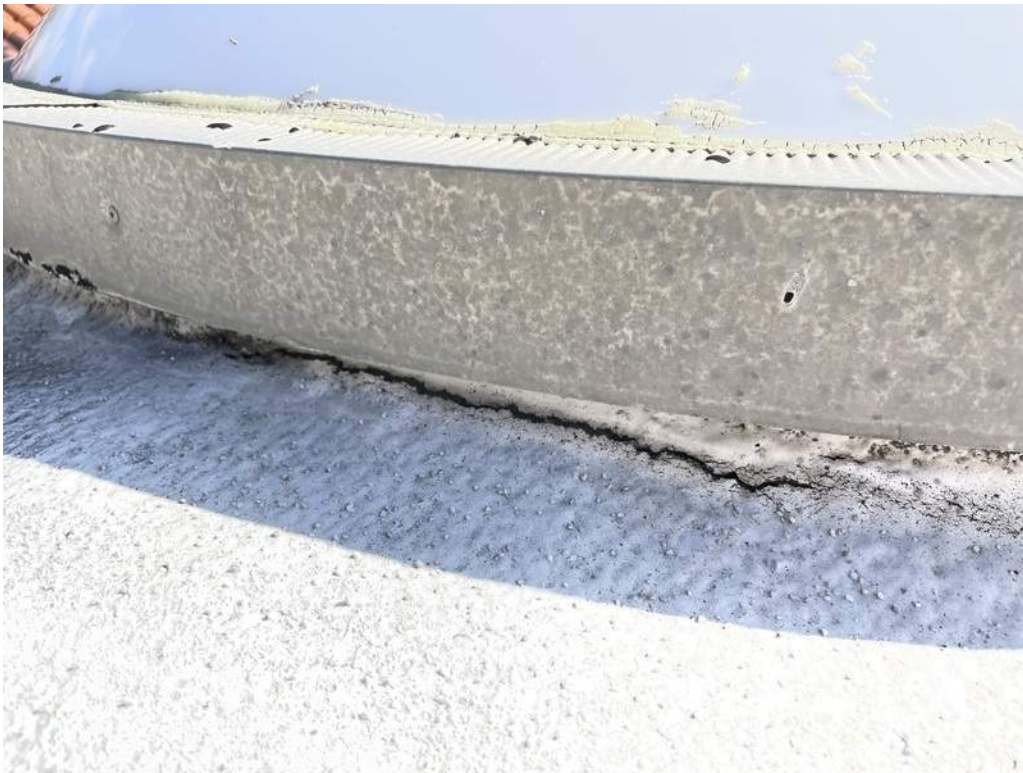
45 - Cracked sealant at the circular dome skylight.

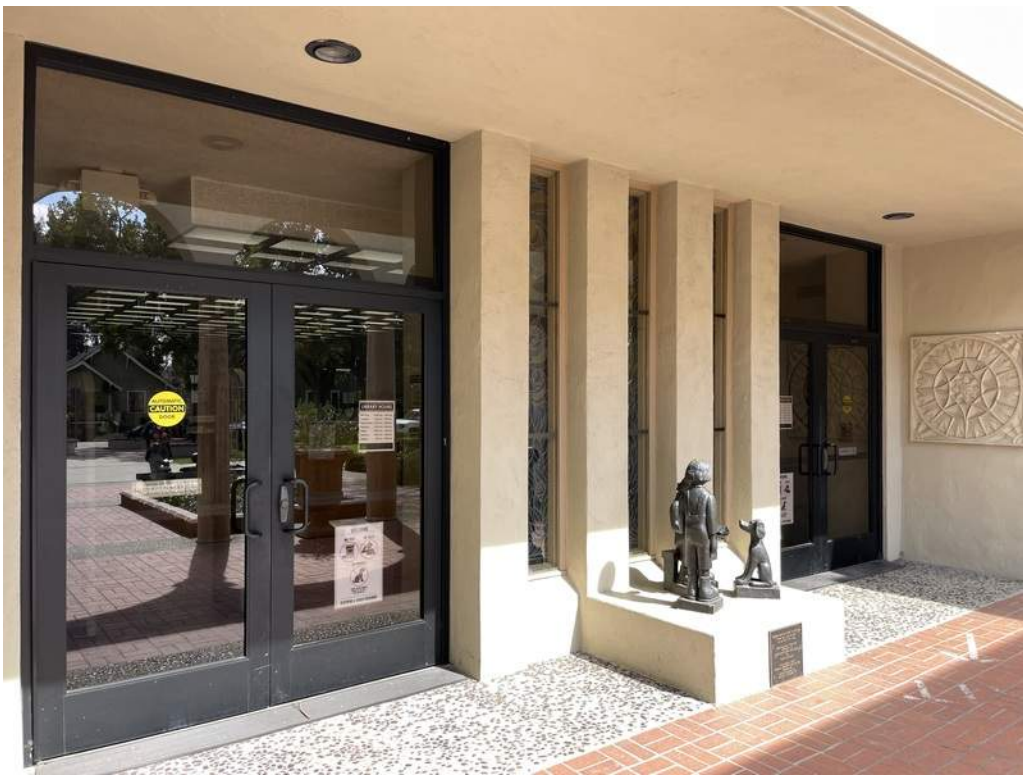
46 - Main entry dark bronze anodized aluminum doors.

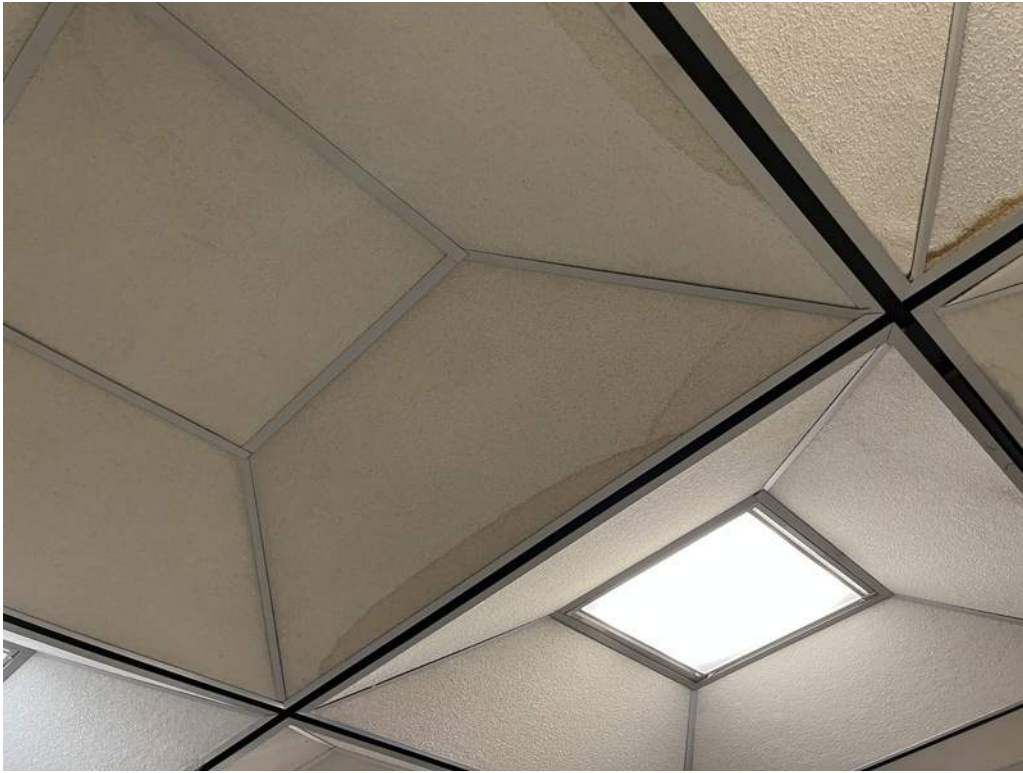
53 - Water damage at the Children's Reading Room acoustical ceiling.

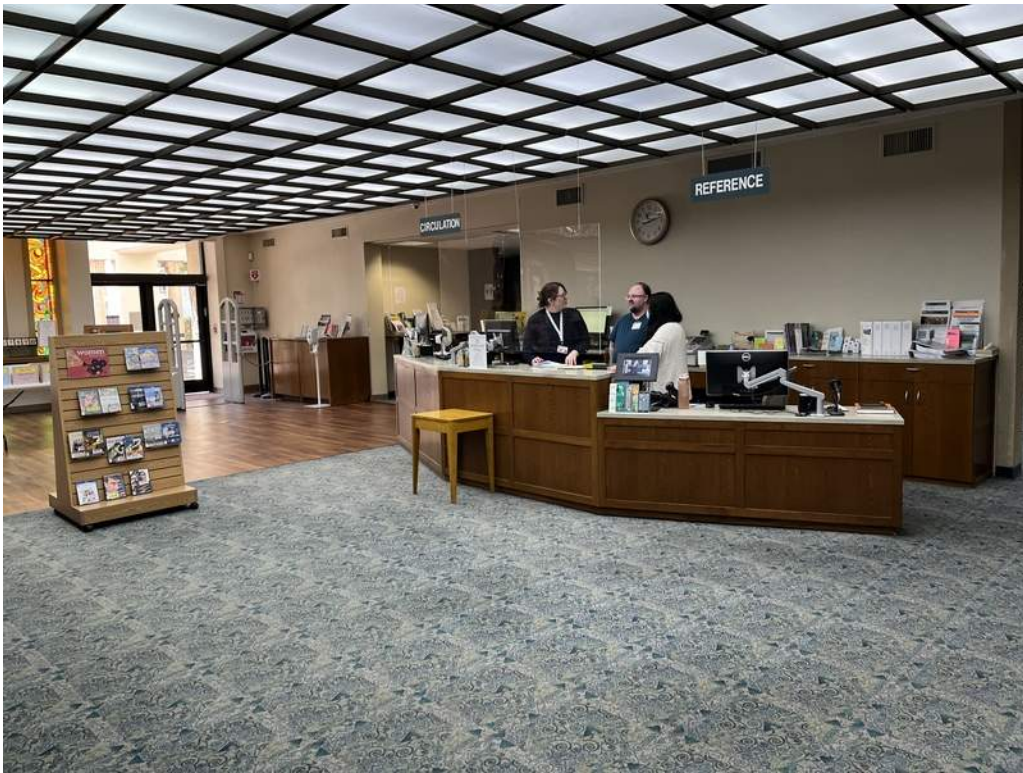
54 - Reference desk and lobby interior finishes.

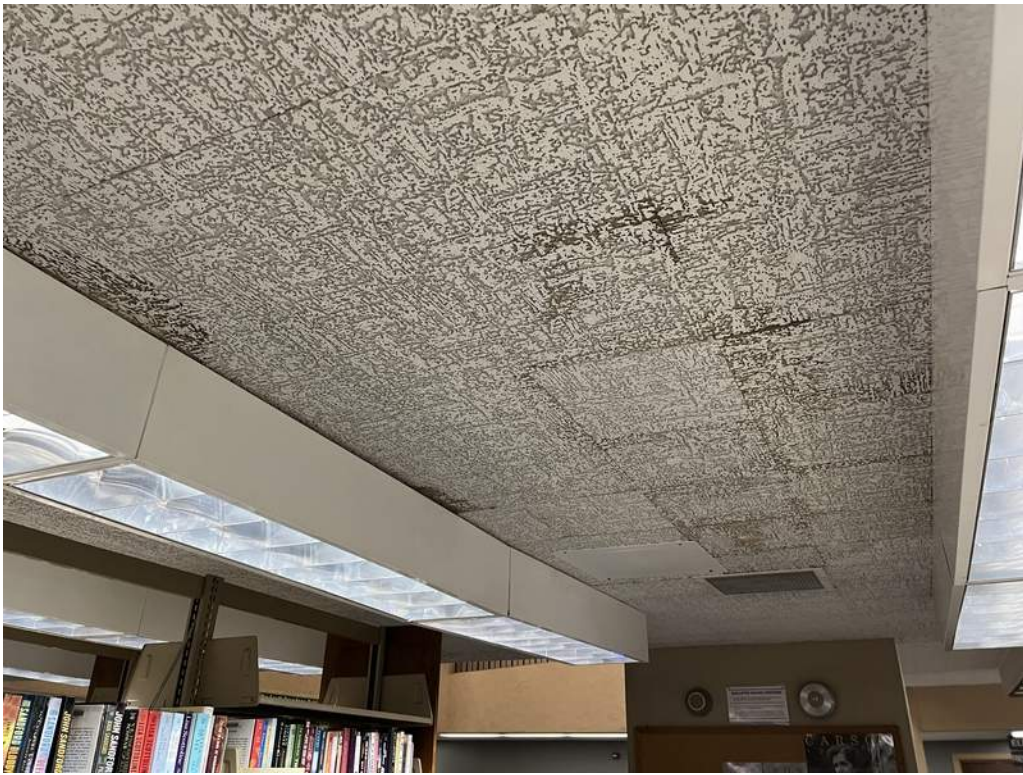
56 - Water damage on the acoustical ceiling in the Reading Room.

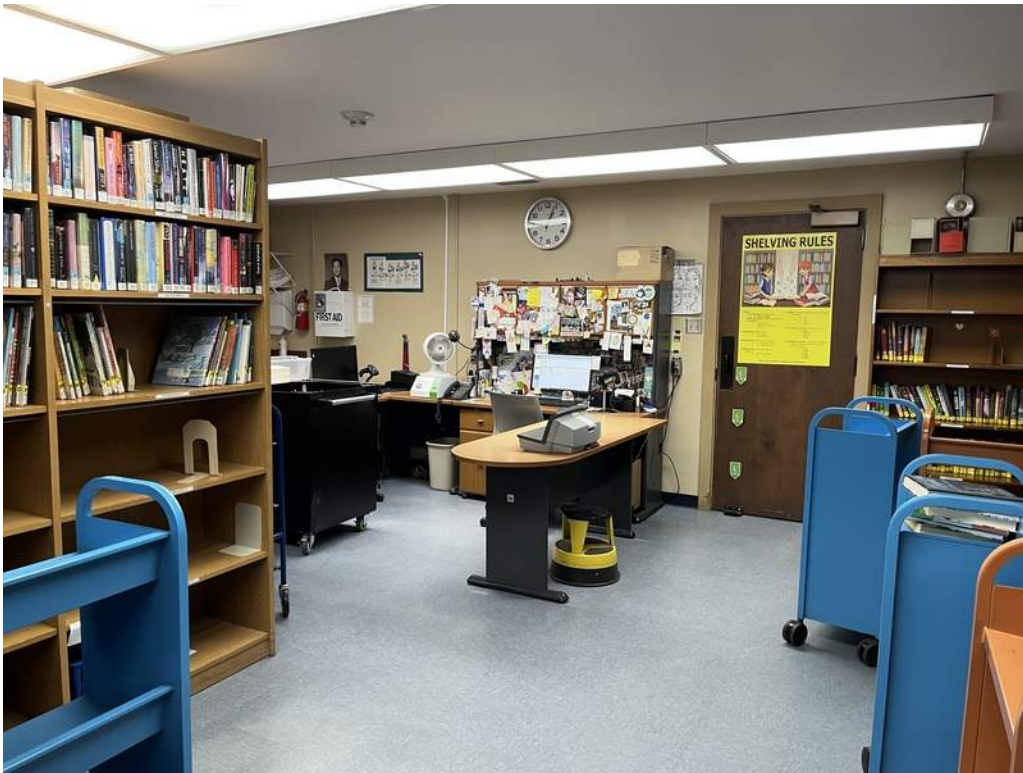
57 - Staff area interior finishes.

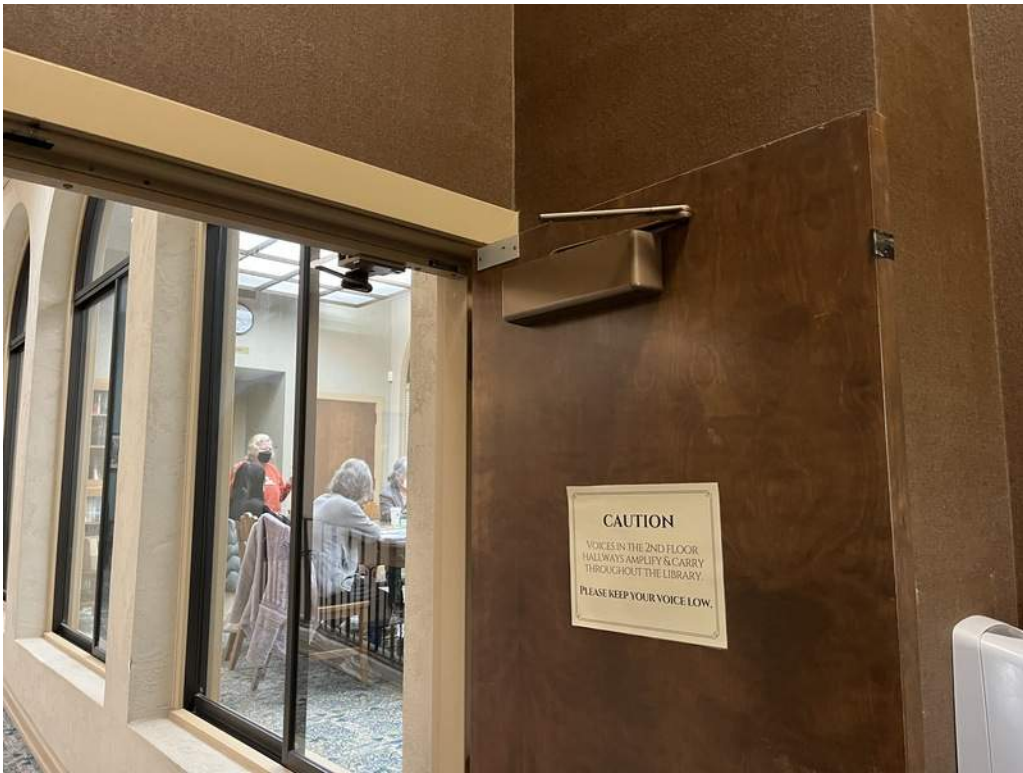
61 - Damaged door closer at the upper level.
