FACILITY CONDITION ASSESSMENT

SOUTH PASADENA PUBLIC LIBRARY

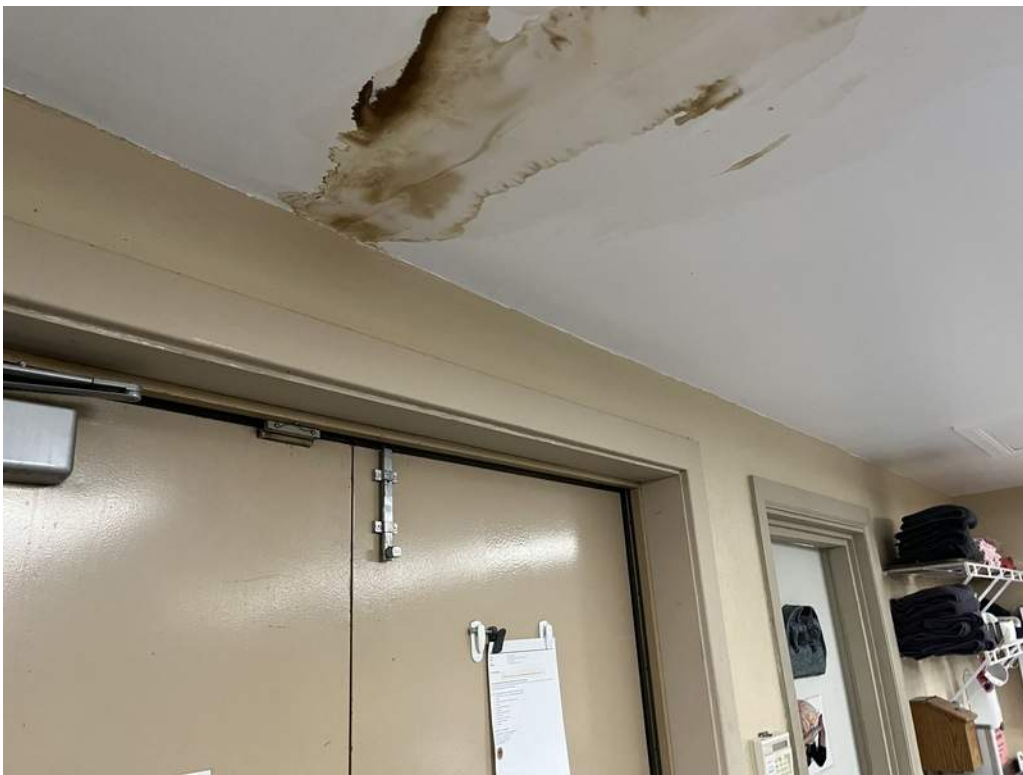
62 - Water damage at the staff area ceiling.

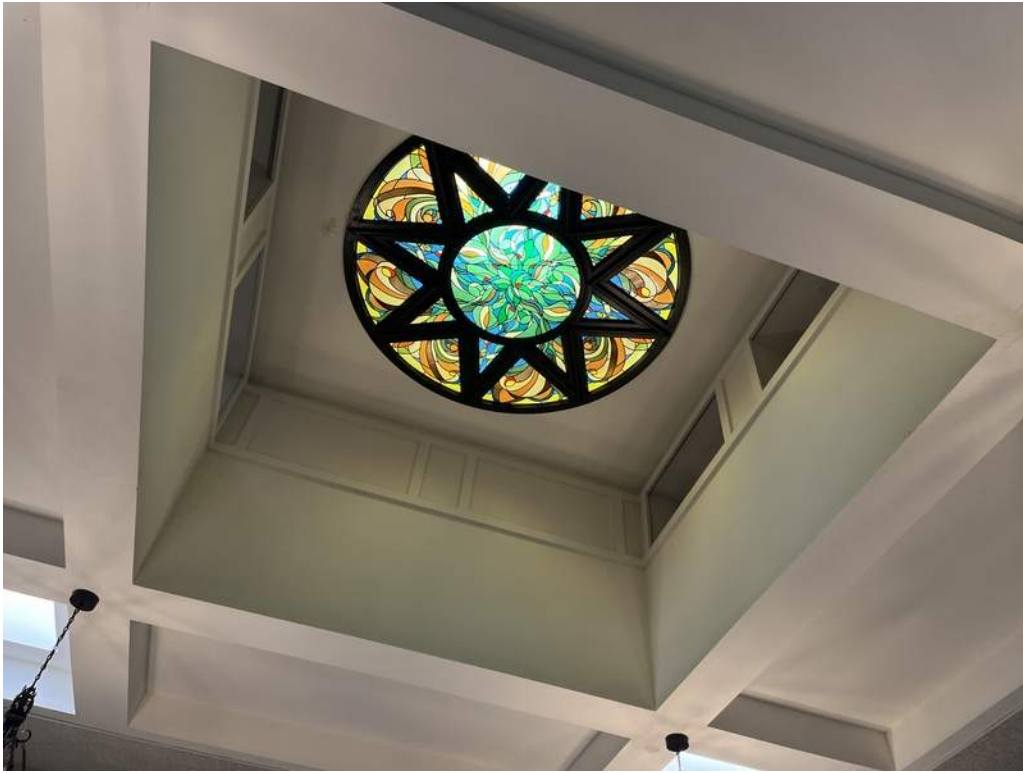
63 - Historic stained glass skylight lens and coffered ceiling at atrium.

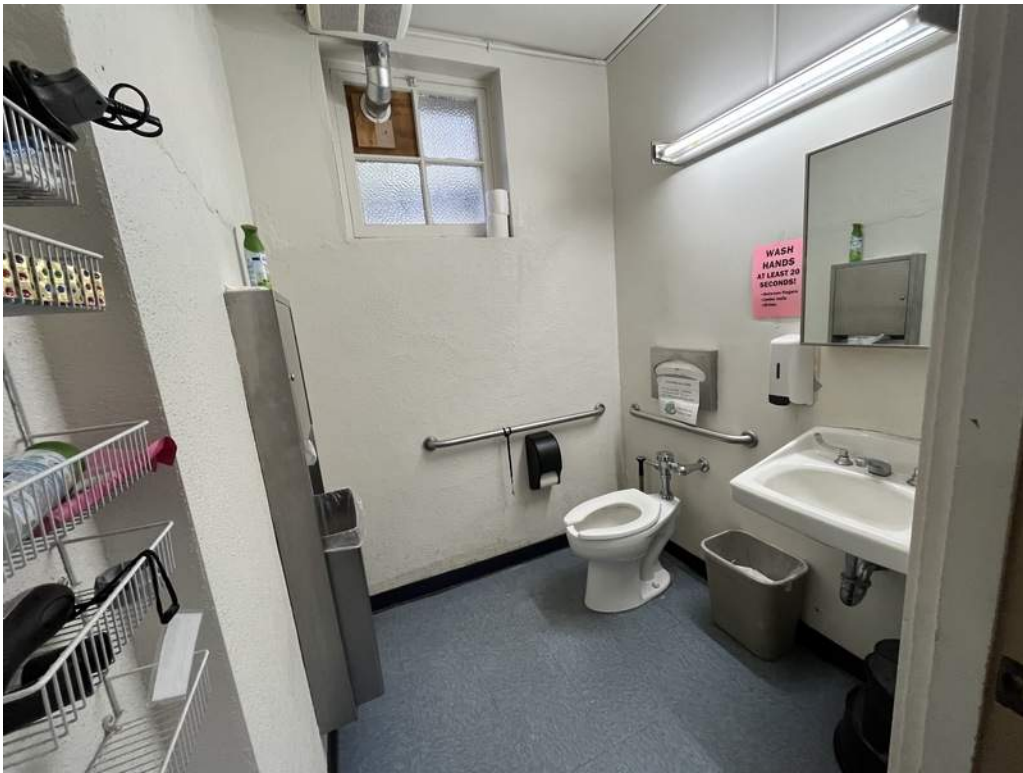
64 - Staff area restroom interior finishes.

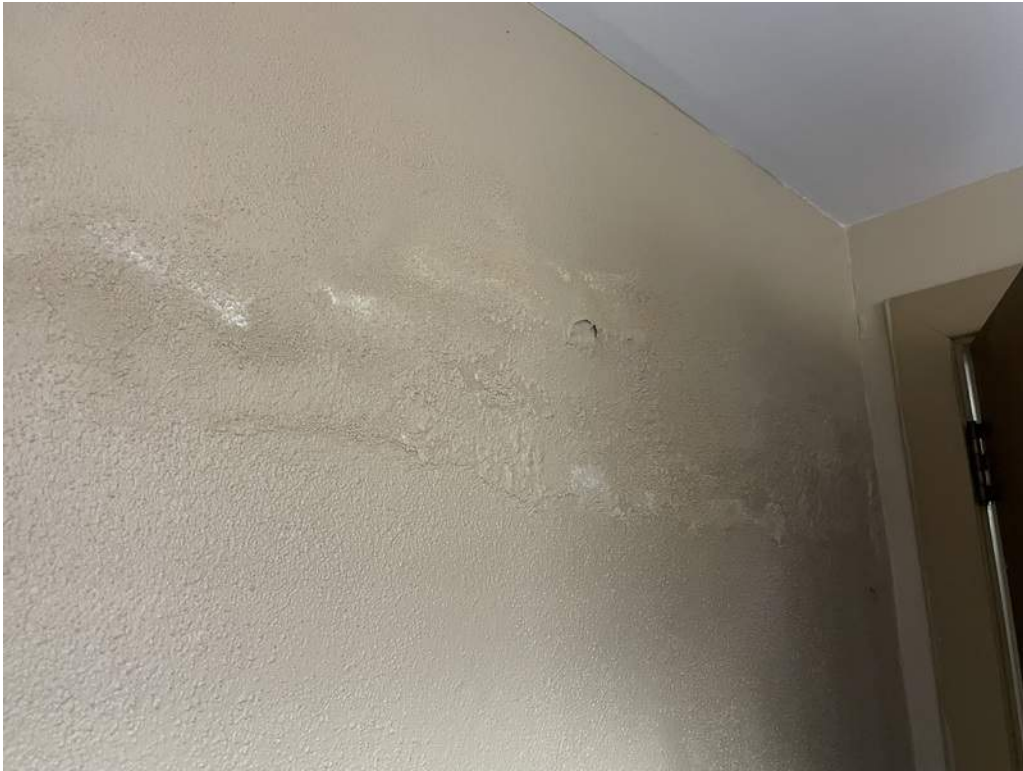
69 - Blistering paint and efflorescence observed in the staff work room.

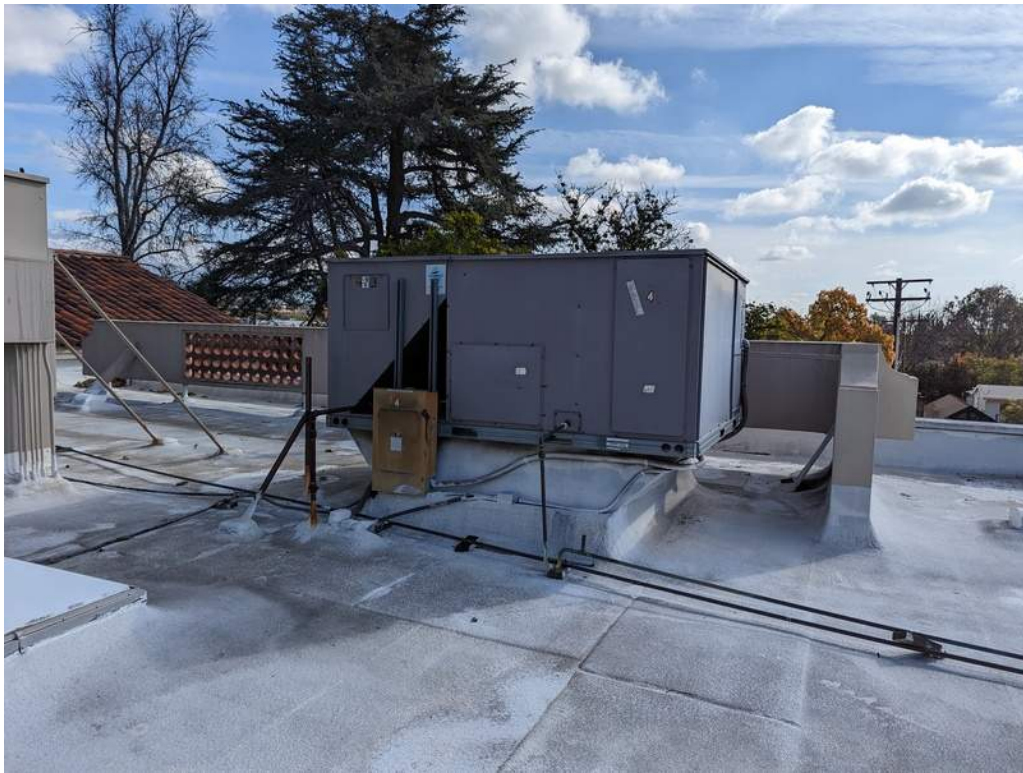
70 - Rooftop packaged unit with electrical disconnect, condensate drain, and natural gas piping.

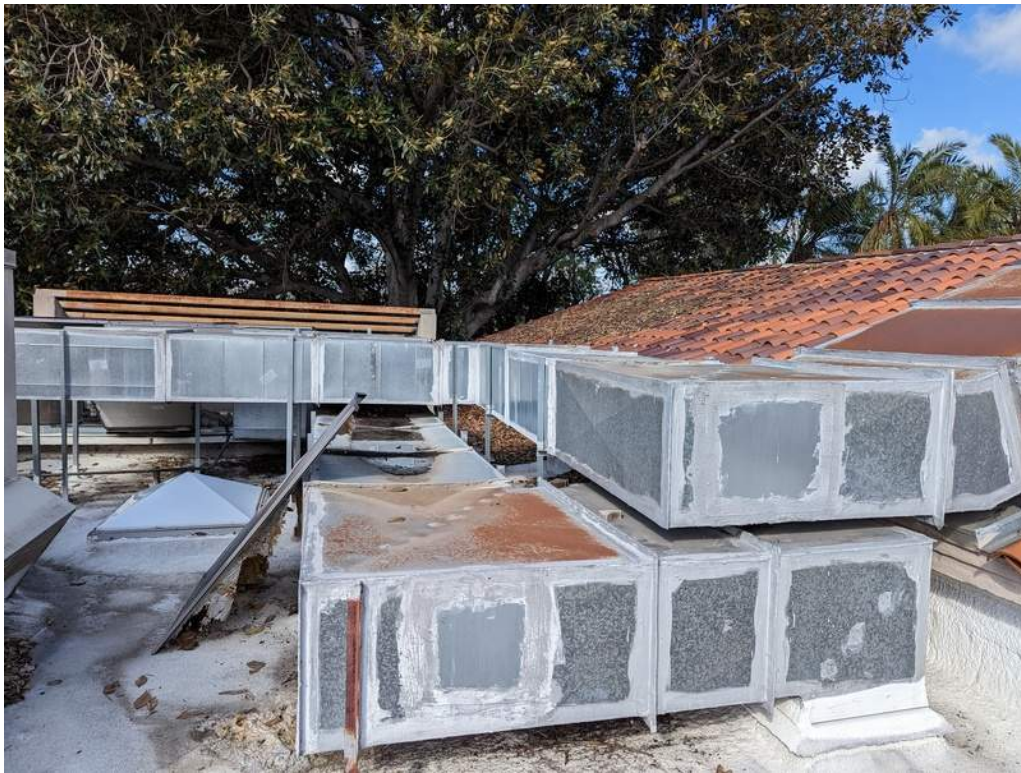
74 - Air ducts mounted on the roof. Ponding water on the top of deformed ducts noted.

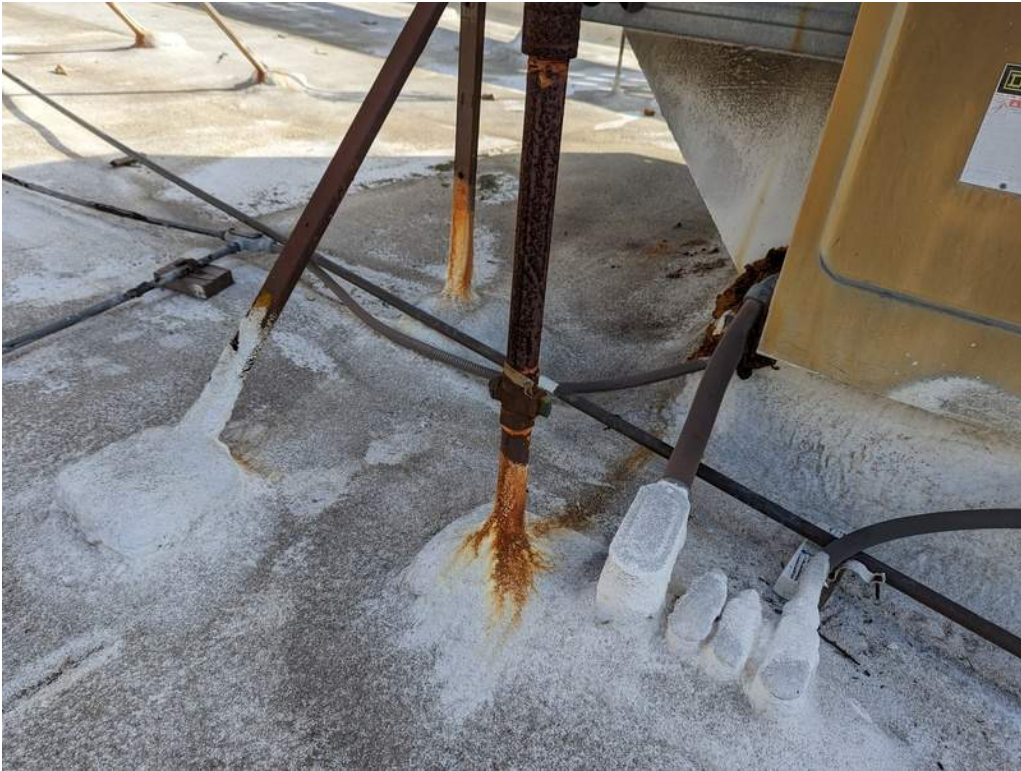
75 - Corroded natural gas piping at the roof.

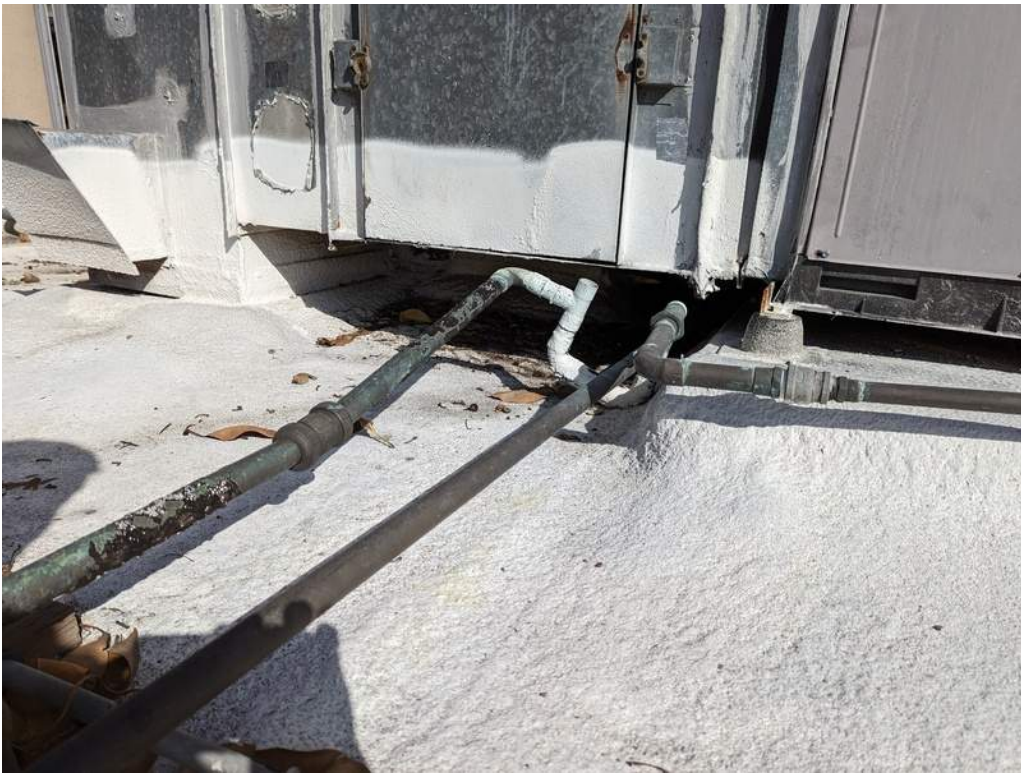
76 - Condensate drain askew and not draining properly.

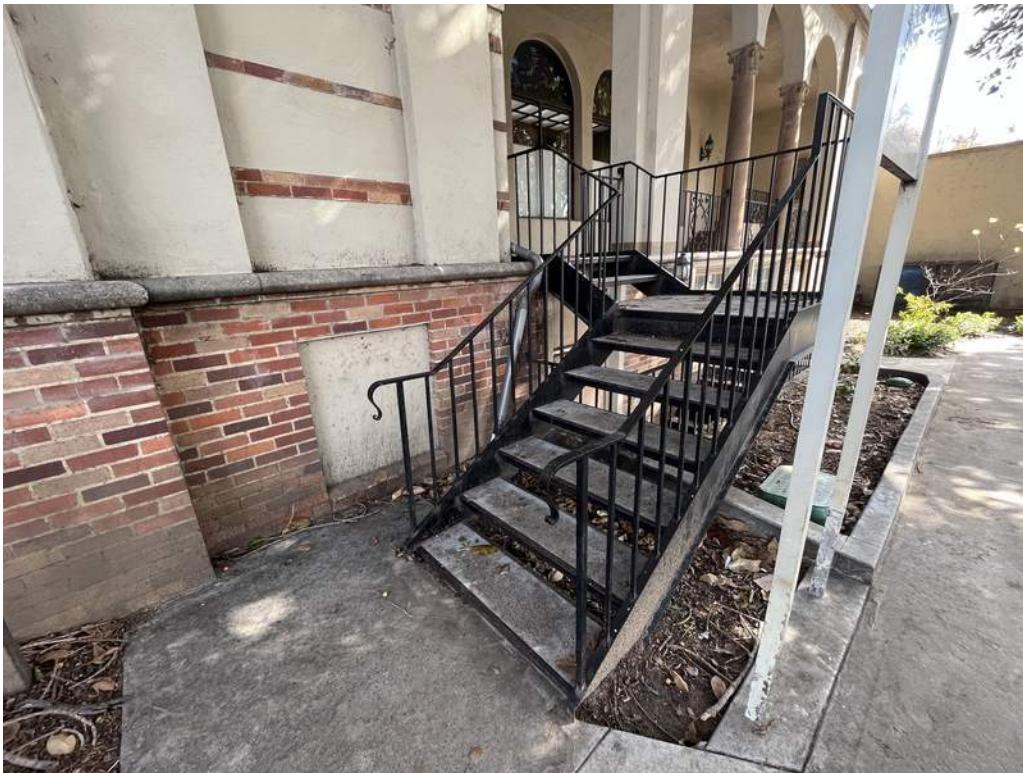
95 - Exterior egress stair with missing handrail extension and open treads.

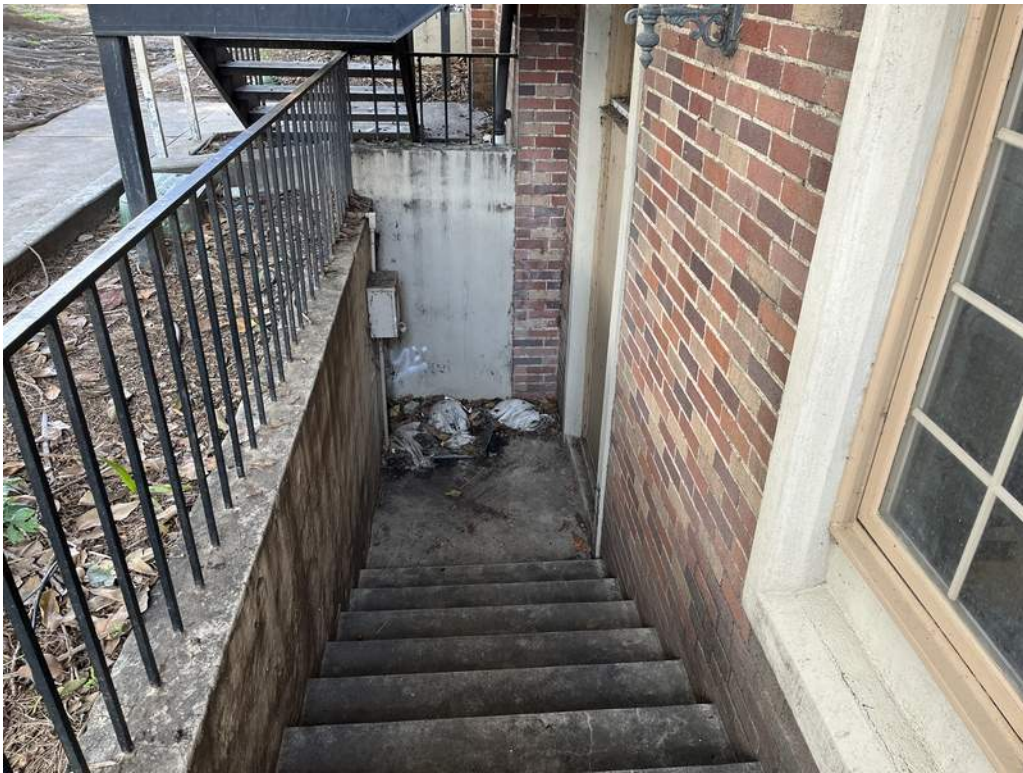
96 - Exterior egress stair with missing handrails.

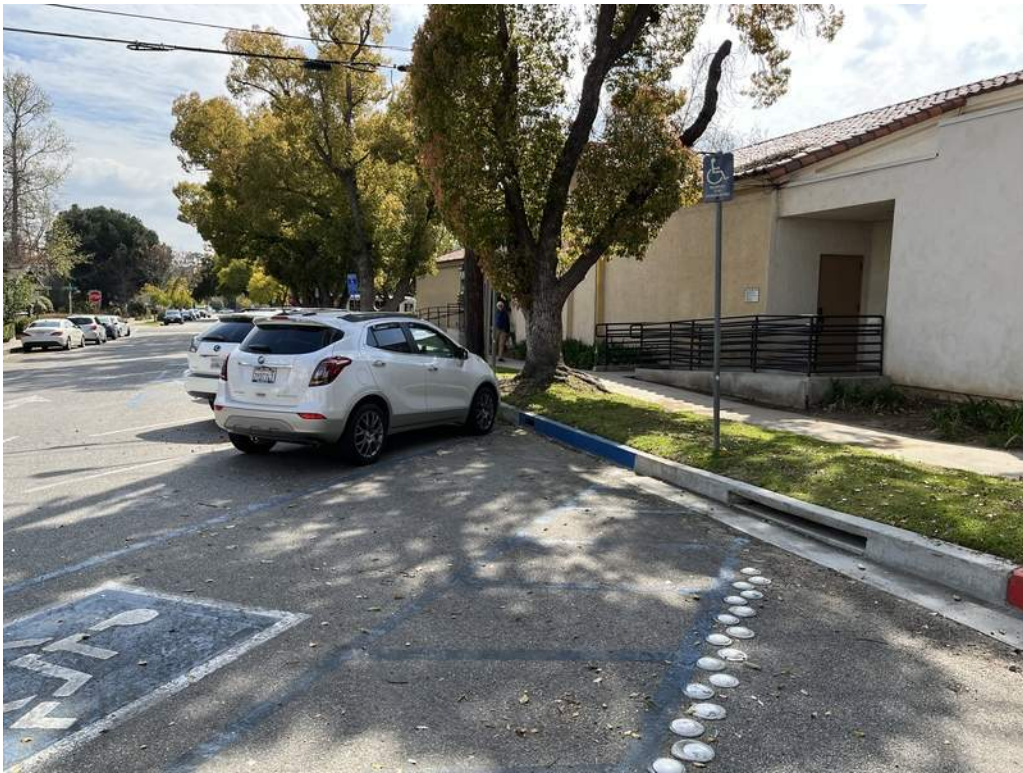
97 - Non-compliant accessible parking spaces without an adjacent curb ramp to the path of travel.

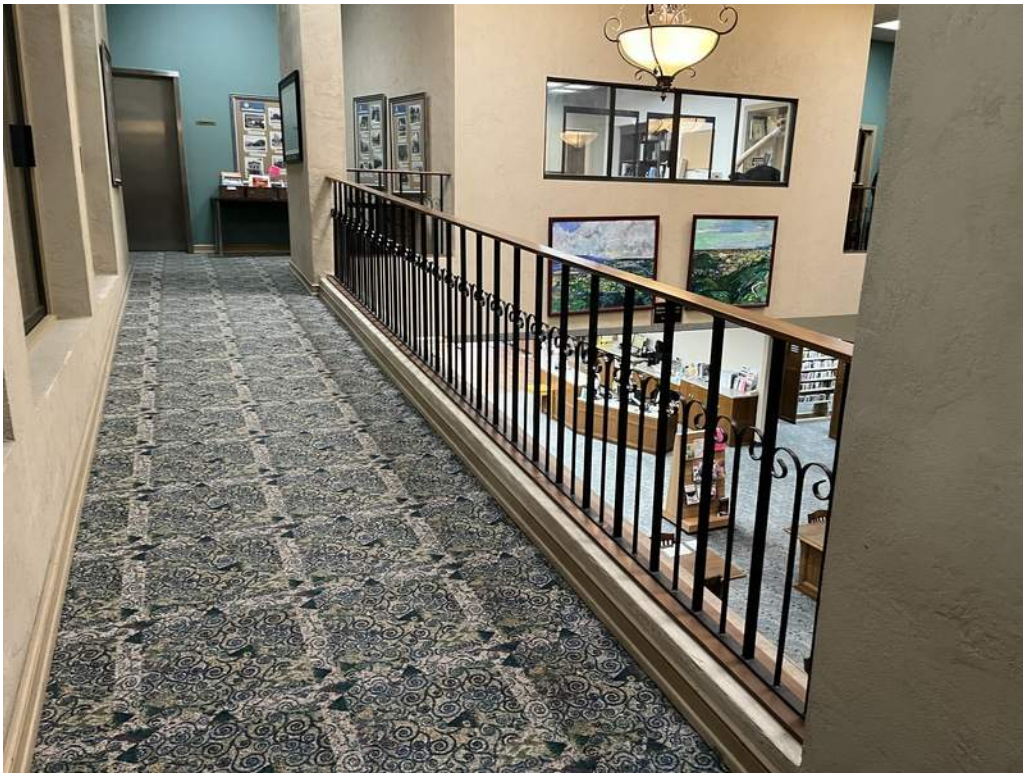
103 - Non-compliant ramps on the upper level with missing handrails.

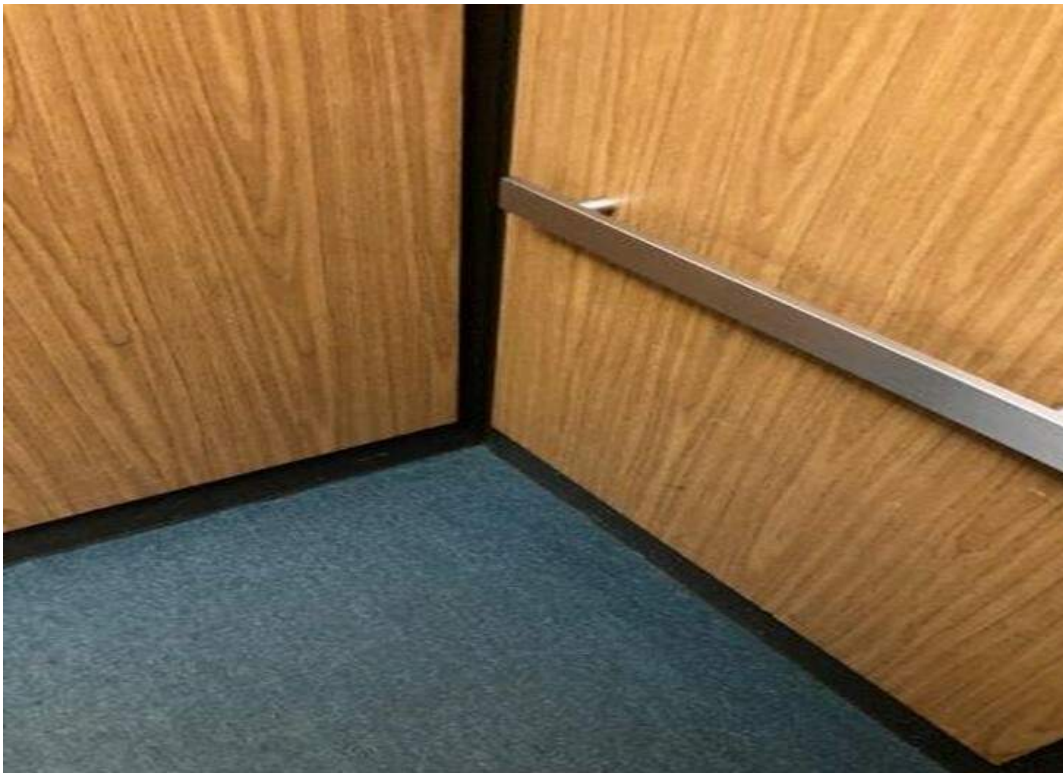
104 - Non-compliant elevator cab interior handrail.

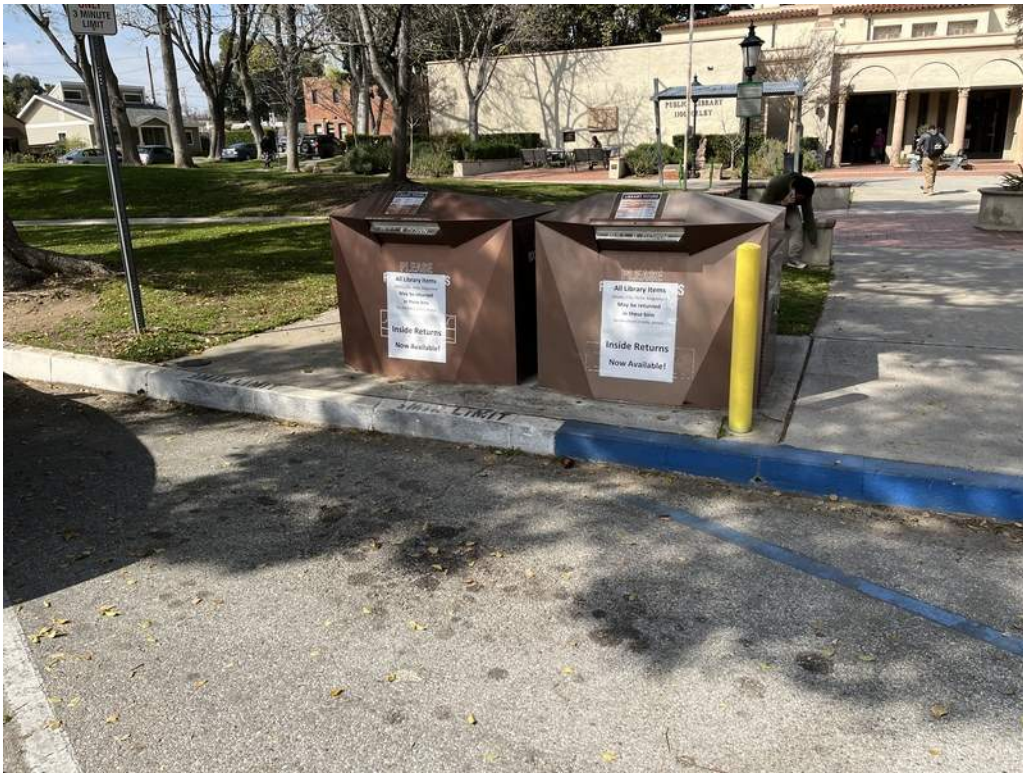
107 - Non-compliant book drop-off boxes observed along Oxley Street.
