CITY OF SOUTH PASADENA CULTURAL HERITAGE COMMISSION

AGENDA REGULAR MEETING THURSDAY, SEPTEMBER 19, 2024 AT 6:30 P.M.

5. 203 Oaklawn Avenue, Project No. MIL24-0001 – The Cultural Heritage Commission (CHC) will review and make a recommendation to the City Council for a proposed Mills Act Contract application (Project No. MIL24-0001) for a residence at 203 Oaklawn Avenue (APN: 5317-014-015). In accordance with the California Environmental Quality Act (CEQA), the project qualifies for an exemption under the CEQA Guidelines Section 15308, Class 8 (Actions by Regulatory Agencies for Protection of the Environment).

203 Oaklawn Avenue
Mills Act Application, Letter of Intent
Attachment: Photographs, 2024

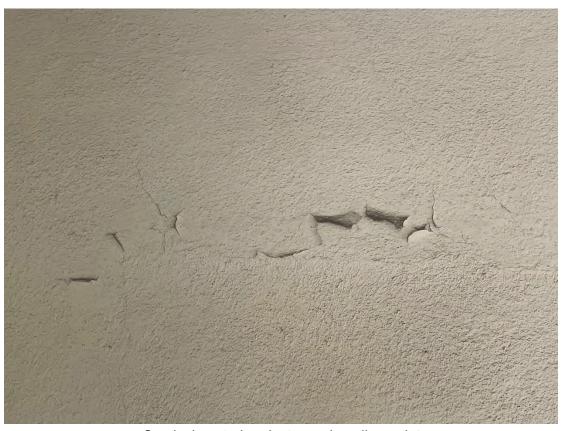
Cracks in exterior plaster and peeling paint

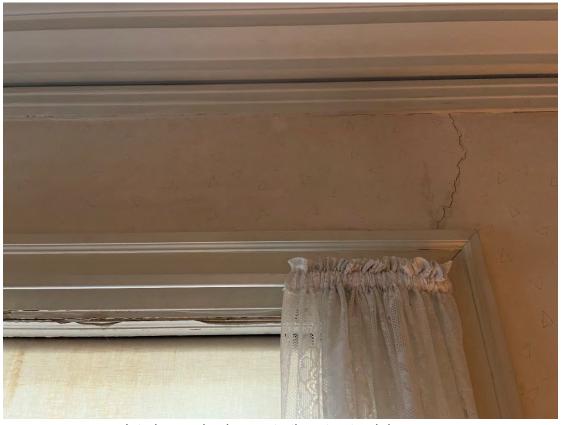
Interior cracks demonstrating structural damage

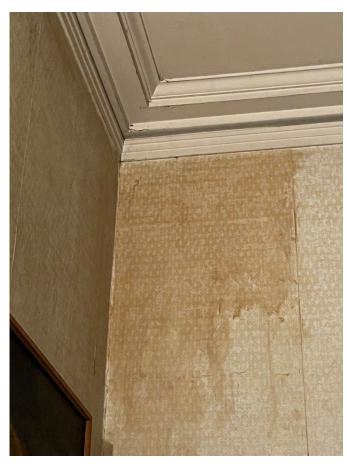
Evidence of roof leaks on the second floor

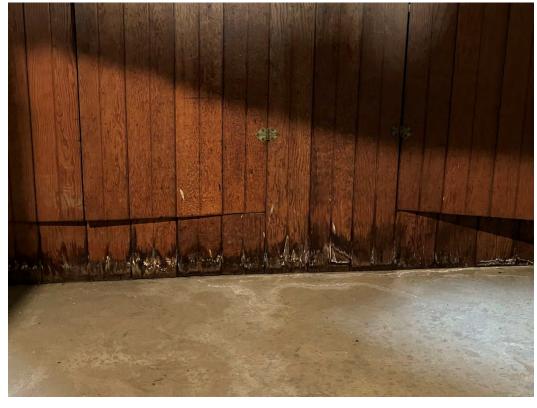
Evidence of drainage issues in the basement

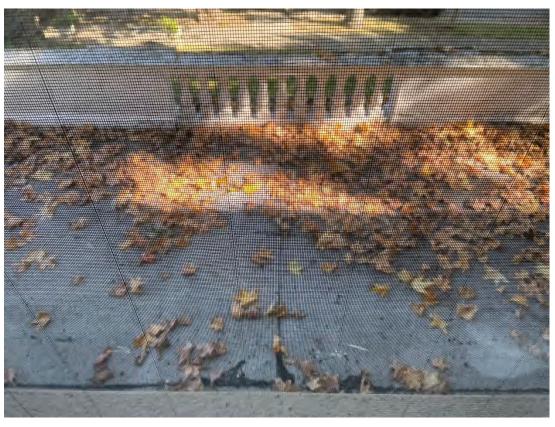
Damaged roof of the porch

- Tear off 1350 sq. ft. shingle roof at the southwest patio, repairs to rotten wood, install new composite shingle roofing material.
- Tear off 260 sq. ft. roof on the front porch, repairs to damaged framing and gutter system, install new torch down bitumen roofing material.

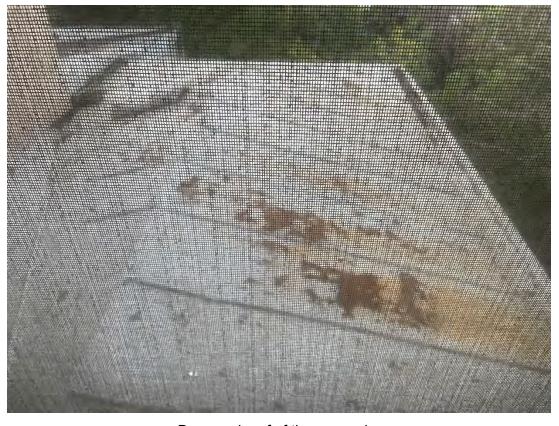
Damaged roof of the sun parlor

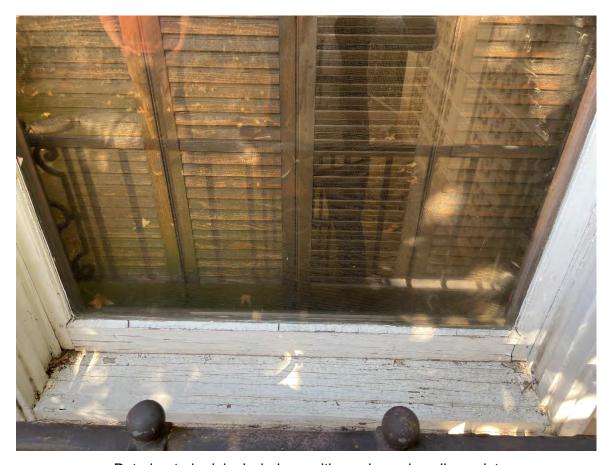
Deteriorated original windows with cracks and peeling paint

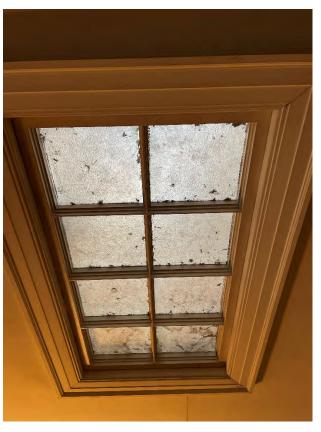
Staircase skylight to be repaired

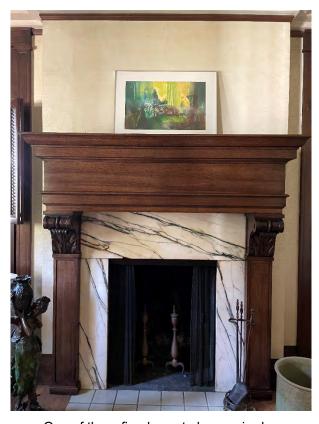
One of three fireplaces to be repaired

15. Repair fire boxes and flue systems in three (3) fireplaces to ensure safety, based on the inspection report.	\$ 54,636 (including work under No. 7)	2028

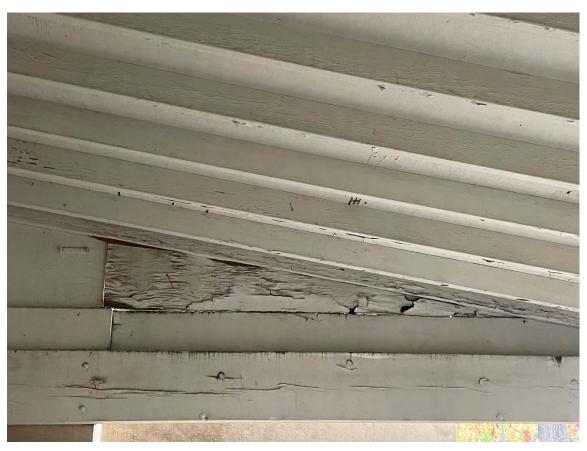
Attached rear porch – roof and foundation damage

21. Partially replace foundation at the southwest patio. Repair cracks in the concrete deck and block porch wall.	\$ 19,287	2030
22. Repair cracks in exterior concrete steps and clinker brick paving.	\$ 15,200	2030

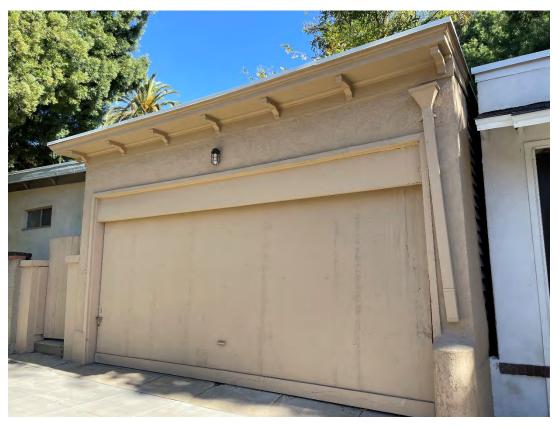
Non-original garage door

23. Reinforce the garage opening and install a steel beam to ensure seismic stability.	\$ 5,640	2031
24. Replace non-original overweight garage door and an outdated opening mechanism with a modern lightweight garage door of historically appropriate design.

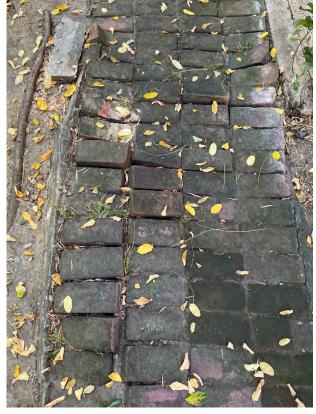
Clinker brick pavement to be repaired

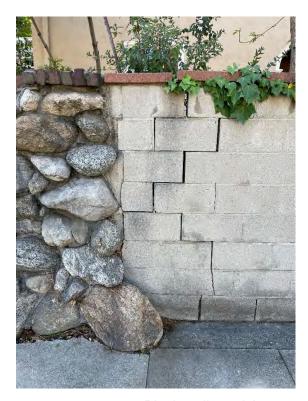
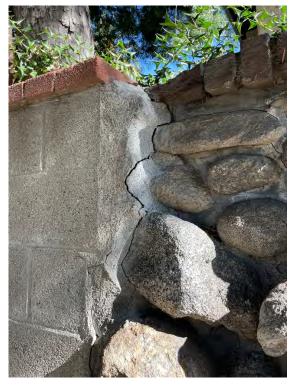
Block walls and Arroyo stone posts to be repaired

11. Repair concrete walls with Arroyo stone posts along the northern and western property lines to avoid public hazard.	\$ 28,000	2026
12. Replace outdated knob and tube electric wiring and ungrounded three prong receptacles with modern wiring to ensure safety, including new 200 Amp service, four (4) sub panels, all new grounded circuits and lighting, arc fault breakers and smoke and carbon dioxide sensors.	\$ 86,000	2027

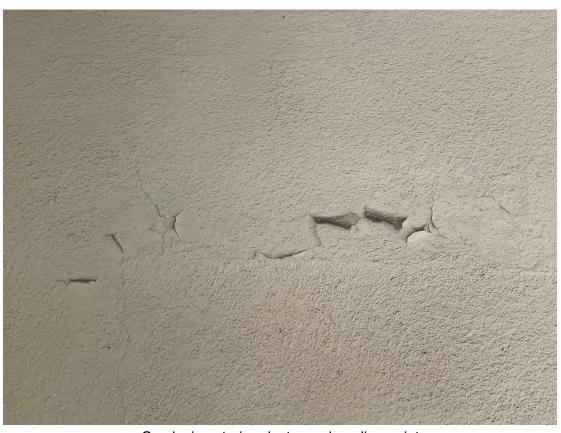
Cracks in exterior plaster and peeling paint

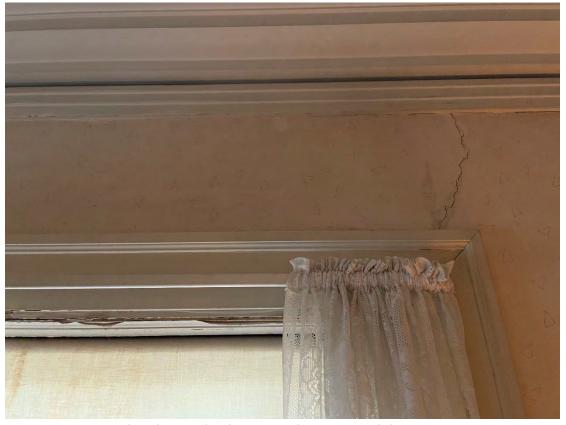
Interior cracks demonstrating structural damage

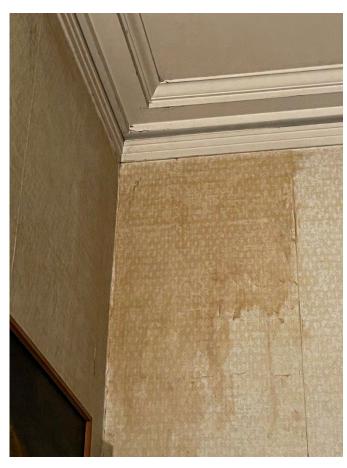
Evidence of roof leaks on the second floor

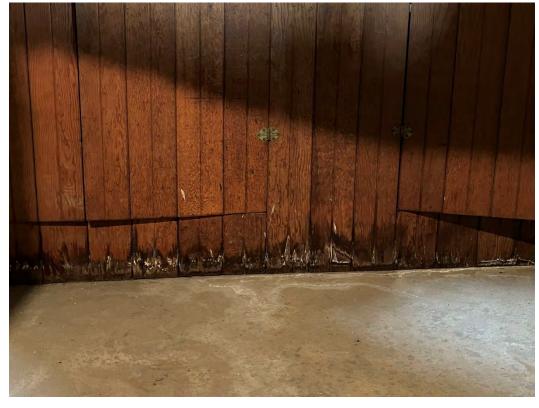
Evidence of drainage issues in the basement

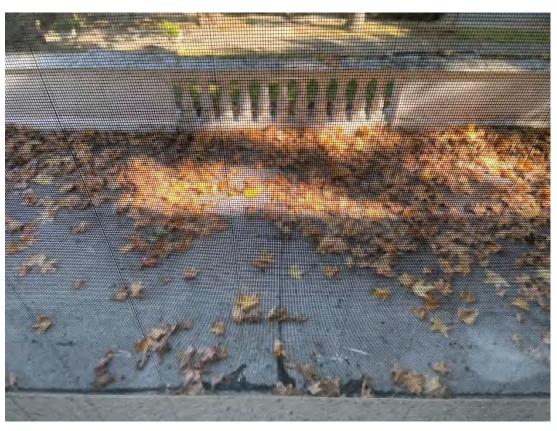
Damaged roof of the porch

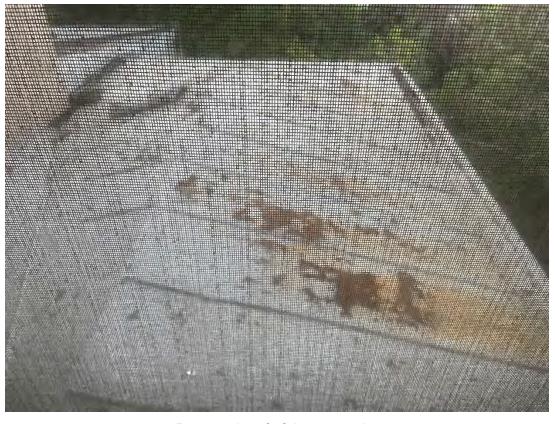
Damaged roof of the sun parlor

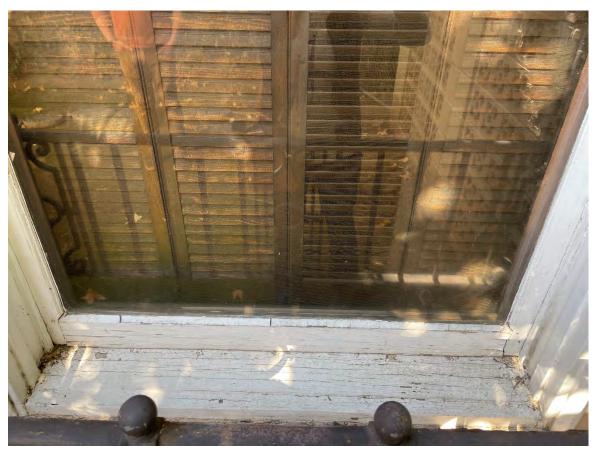
Deteriorated original windows with cracks and peeling paint

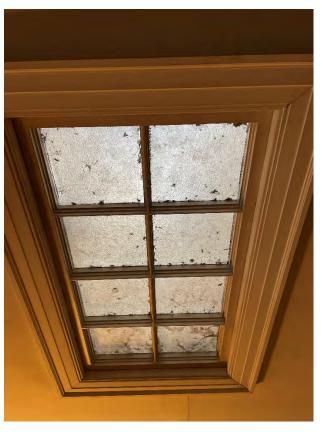
Staircase skylight to be repaired

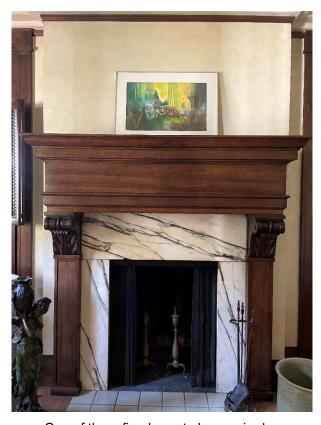
One of three fireplaces to be repaired

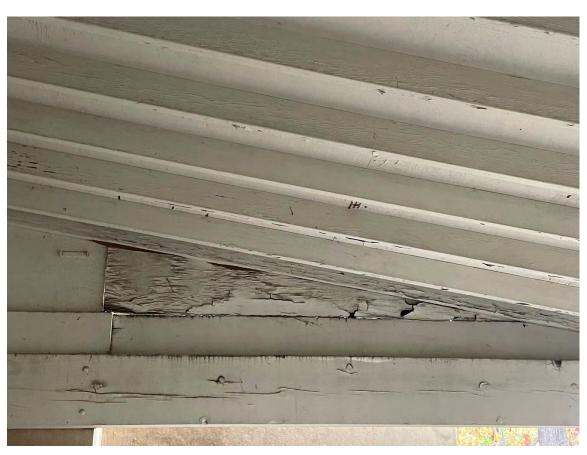
Attached rear porch – roof and foundation damage

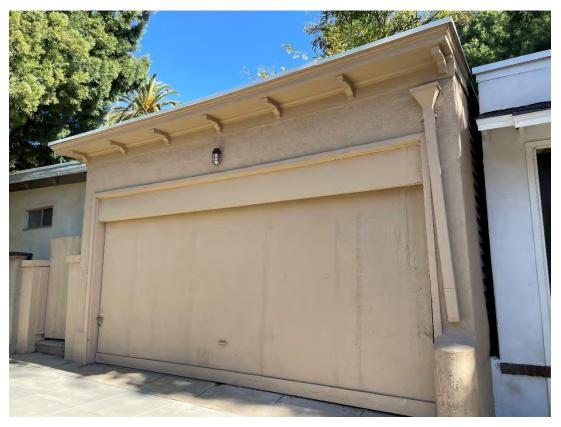
Non-original garage door

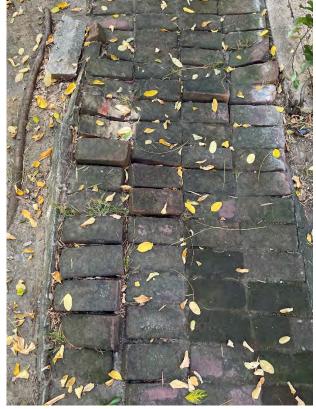
Clinker brick pavement to be repaired

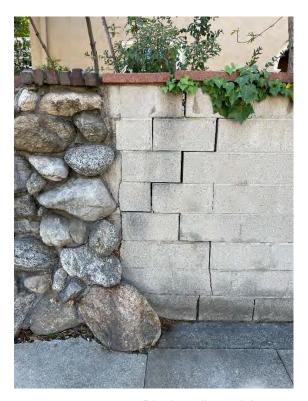
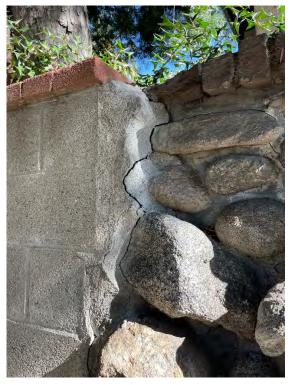
Block walls and Arroyo stone posts to be repaired
